DEPARTMENT OF TRANSPORTATION

Contract #: 04-0120F4Cty: SF/ALA Rte: 80 PM: 13.2/13.9File #: 1.28**WELDING INSPECTION REPORT****Resident Engineer:** Siegenthaler, Peter**Address:** 333 Burma Road**City:** Oakland, CA 94607**Report No:** WIR-026191**Date Inspected:** 25-Aug-2011**Project Name:** SAS Superstructure**OSM Arrival Time:** 700**Prime Contractor:** American Bridge/Fluor Enterprises, a JV**OSM Departure Time:** 1530**Contractor:** American Bridge/Fluor Enterprises, a JV**Location:** Job Site**CWI Name:** John Pagliero**CWI Present:** Yes No**Inspected CWI report:** Yes No N/A**Rod Oven in Use:** Yes No N/A**Electrode to specification:** Yes No N/A**Weld Procedures Followed:** Yes No N/A**Qualified Welders:** Yes No N/A**Verified Joint Fit-up:** Yes No N/A**Approved Drawings:** Yes No N/A**Approved WPS:** Yes No N/A**Delayed / Cancelled:** Yes No N/A**Bridge No:** 34-0006**Component:** SAS Tower**Summary of Items Observed:**

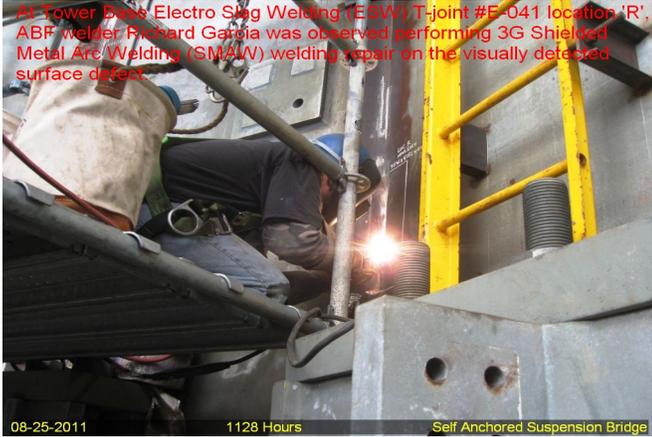
At Tower Base Elevation Electro Slag Welding (ESW) T-joint E-041 location 'R', QA randomly ABF welder Richard Garcia continuing to perform 3G SMAW first time welding repair (R1) on the visually (VT) detected surface defect of the vertical weld of the ESW. The welder was observed welding in the 3G (vertical) position utilizing Shielded Metal Arc Welding (SMAW) with 1/8" diameter E7018H4R electrode implementing welding procedure ABF-WPS-D15-1000-Repair Rev. 2. The boat shape repair excavation located at Y=6460mm was excavated to dimensions of 225mm long x 75mm wide x 40mm deep. The excavation was previously tested using Magnetic Particle Testing (MT) by ABF QC Fred Von Hoff and this QA with positive result. The repair excavation and the adjacent base metal was preheated and maintained to more than 204°C (400°F) using Miller Proheat Induction Heating System with the heater blankets placed at the other side of the repair. During the shift, ABF QC John Pagliero was noted monitoring the welder. Measured welding parameter during welding was 135 amperes on a 1/8" diameter E7018H4R electrode. During the shift, cover pass repair welding was completed including grinding/cleaning of the weld cover. The welder has programmed the Miller Proheat 35 Induction Heating System to hold the preheat of 400°F for three hours and cool down at 150°F per hour as recommended by ABF.

randomly ABF welder Richard Garcia perform 3G SMAW first time welding repair (R1) on the visually detected surface defect of the vertical weld of the ESW. The welder was observed welding in the 3G (vertical) position utilizing Shielded Metal Arc Welding (SMAW) with 1/8" diameter E7018H4R electrode implementing welding procedure ABF-WPS-D15-1000-Repair Rev. 2. The boat shape repair located at Y=2325mm was excavated to dimensions of 475mm long x 75mm wide x 40mm deep. The excavation was previously tested using Magnetic Particle Testing (MT) by ABF QC Steve Mc Connell and verified by this QA with positive result. The repair excavation and the adjacent base metal was preheated and maintained to more than 204°C (400°F) using Miller Proheat Induction Heating System with the heater blankets placed at the other side of the repair. During the shift, ABF QC John Pagliero was noted monitoring the welder. Measured welding parameter during welding was 135 amperes on a 1/8" diameter E7018H4R electrode. During the shift, fill pass repair welding was still continuing and the observation of the job was turned over to Lead QA Danny Reyes for the remainder of the shift.

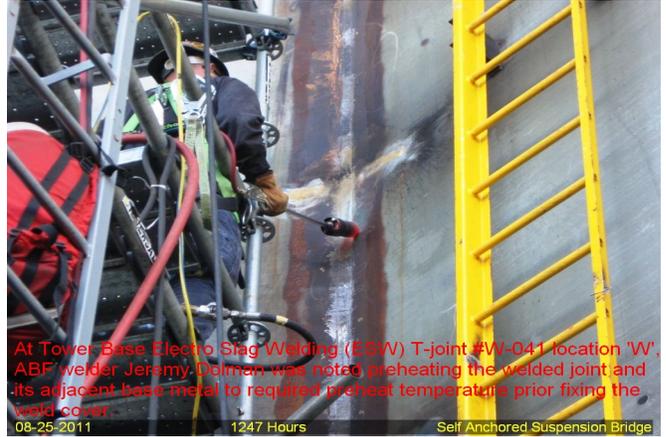
At Tower Base Elevation Electro Slag Welding (ESW) T-joint N-041 location 'N', QA randomly ABF welder Jeremy Dolman continuing to perform 3G SMAW first time welding repair (R1) on the Ultrasonic Testing (UT) detected defect on the vertical weld of the ESW. The welder was observed welding in the 3G (vertical) position utilizing Shielded Metal Arc Welding (SMAW) with 1/8" diameter E7018H4R electrode implementing welding procedure ABF-WPS-D15-1000-Repair Rev. 2. The boat shape repair located at Y=7000mm was excavated to dimensions of 210mm long x 45mm wide x 40mm deep. The excavation was tested using Magnetic Particle Testing (MT) by ABF QC John Pagliero and this QA with positive result. The repair excavation and the adjacent base metal was preheated and maintained to more than 204°C (400°F) using Miller Proheat Induction Heating System with the heater blankets placed at the other side of the repair area. During the shift, ABF QC John Pagliero was noted monitoring the welder. Measured welding parameter during welding was 115 amperes on a 1/8" diameter E7018H4R electrode. During the shift, cover pass repair welding was completed including grinding/cleaning of the weld cover. The welder has programmed the Miller Proheat 35 Induction Heating System to hold the preheat of 204°C (400°F) for three hours and cool down at 150°F per hour as recommended by ABF.
