Contract #: 04-0120F4Cty: SF/ALA Rte: 80 PM: 13.2/13.9File #: 1.28**WELDING INSPECTION REPORT****Resident Engineer:** Siegenthaler, Peter**Address:** 333 Burma Road**City:** Oakland, CA 94607**Report No:** WIR-026194**Date Inspected:** 26-Aug-2011**Project Name:** SAS Superstructure**OSM Arrival Time:** 700**Prime Contractor:** American Bridge/Fluor Enterprises, a JV**OSM Departure Time:** 1530**Contractor:** American Bridge/Fluor Enterprises, a JV**Location:** Job Site

WELDING INSPECTION REPORT

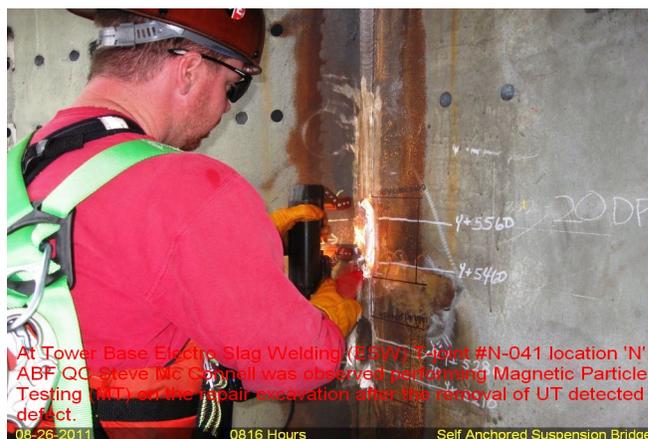
At Tower Base Electro Slag Welding (ESW) T-joint # N-041 location 'N', ABF QC Steve Mc Connell was observed performing Magnetic Particle Testing (MT) on the excavation of Ultrasonic Testing (UT) detected defect

at two locations; Y=4980mm having excavation dimensions of 175mm long x 45mm wide x 24mm wide and at Y=5245mm having excavation dimensions of 180mm long x 45mm wide x 20mm deep. Both boat shape repair excavations defect removal MT were found acceptable by QC Steve Mc Connell. This QA performed the same test (MT) and noted same result. According to ABF QC, they will submit the excavation details including photographs to ABF/Caltrans and wait for the Request for Welding Repair (RWR) approval prior to commence repair welding.
