DEPARTMENT OF TRANSPORTATION

Contract #: 04-0120F4Cty: SF/ALA Rte: 80 PM: 13.2/13.9File #: 1.28**WELDING INSPECTION REPORT****Resident Engineer:** Siegenthaler, Peter**Address:** 333 Burma Road**City:** Oakland, CA 94607**Report No:** WIR-026196**Date Inspected:** 27-Aug-2011**Project Name:** SAS Superstructure**OSM Arrival Time:** 700**Prime Contractor:** American Bridge/Fluor Enterprises, a JV**OSM Departure Time:** 1530**Contractor:** American Bridge/Fluor Enterprises, a JV**Location:** Job Site

WELDING INSPECTION REPORT

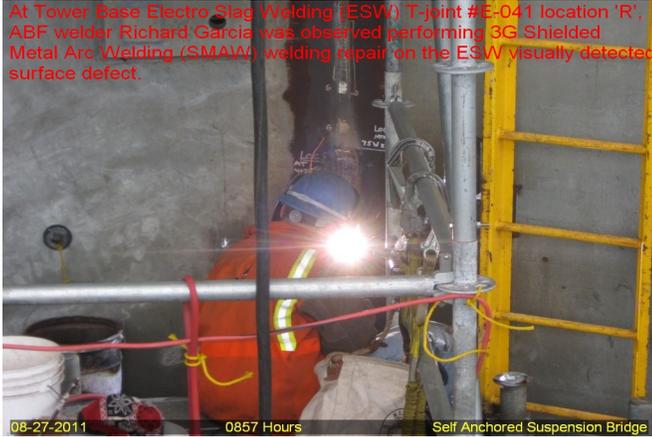
At Tower Base Elevation Electro Slag Welding (ESW) T-joint E-041 location 'R', QA randomly ABF welder Richard Garcia continuing to perform 3G SMAW first time welding repair (R1) on the visually (VT) detected defect on the surface of the vertical weld of the ESW. The welder was observed welding in the 3G (vertical) position utilizing Shielded Metal Arc Welding (SMAW) with 1/8" diameter E7018H4R electrode implementing welding procedure ABF-WPS-D15-1000-Repair Rev. 2. The boat shape repair excavation located at Y=2325mm to Y=2800mm was excavated to dimensions of 475mm long x 75mm wide x 40mm deep. The excavation was previously tested using Magnetic Particle Testing (MT) by ABF QC Steve Mc Connell and this QA with positive result. The repair excavation and the adjacent base metal was preheated and maintained to more than 204°C (400°F) using Miller Proheat Induction Heating System with the heater blankets placed at the other side of the repair. During the shift, ABF QC John Pagliero was noted monitoring the welder. Measured welding parameter during welding was 138 amperes on a 1/8" diameter E7018H4R electrode. During the shift, cover pass repair welding was still continuing and should remain tomorrow. At the end of the shift, the welder has programmed the Miller Proheat 35 Induction Heating System to hold the preheat of 400°F for three hours and cool down at 150°F per hour as recommended by ABF.

At Tower Base Electro Slag Welding (ESW) T-joint #E-041 location 'R', ABF welder Richard Garcia was observed performing 3G Shielded Metal Arc Welding (SMAW) welding repair on the ESW visually detected surface defect.

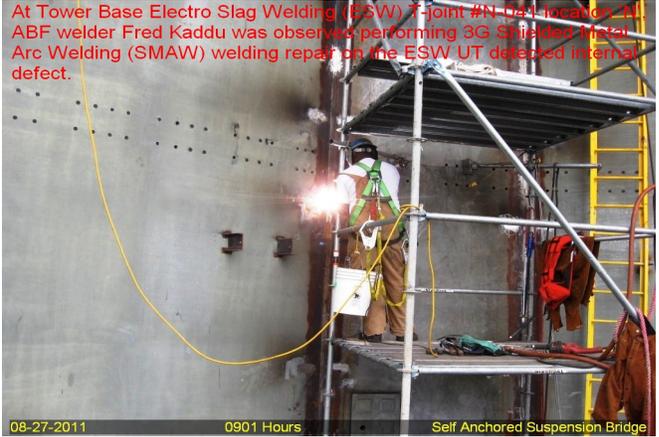
At Tower Base Elevation Electro Slag Welding (ESW) T-joint N-041 location 'N', QA randomly ABF welder Fred Kaddu perform 3G SMAW first time welding repair (R1) on the Ultrasonic Testing (UT) detected defect on

the vertical weld of the ESW. The welder was observed welding in the 3G (vertical) position utilizing Shielded Metal Arc Welding (SMAW) with 1/8" diameter E7018H4R electrode implementing welding procedure ABF-WPS-D15-1000-Repair Rev. 2. The boat shape repair excavation located at Y=5065mm was excavated to dimensions of 175mm long x 45mm wide x 20mm deep. The excavation was previously tested using Magnetic Particle Testing (MT) by ABF QC Steve Mc Connell and this QA with positive result. The repair excavation and the adjacent base metal was preheated and maintained to more than 204°C (400°F) using Miller Proheat Induction Heating System with the heater blankets placed at the other side of the repair. During the shift, ABF QC John Pagliero was noted monitoring the welder. Measured welding parameter during welding was 140 amperes on a 1/8" diameter E7018H4R electrode. During the shift, cover pass repair welding was completed.

At Tower Base Electro Slag Welding (ESW) T-joint #N-041 location 'L', ABF welder Fred Kaddu was observed performing 3G Shielded Metal Arc Welding (SMAW) welding repair on the ESW UT detected internal defect.
