**DEPARTMENT OF TRANSPORTATION**

Contract #: 04-0120F4Cty: SF/ALA Rte: 80 PM: 13.2/13.9File #: 1.28**WELDING INSPECTION REPORT****Resident Engineer:** Siegenthaler, Peter**Address:** 333 Burma Road**City:** Oakland, CA 94607**Report No:** WIR-026241**Date Inspected:** 01-Sep-2011**Project Name:** SAS Superstructure**OSM Arrival Time:** 700**Prime Contractor:** American Bridge/Fluor Enterprises, a JV**OSM Departure Time:** 1730**Contractor:** American Bridge/Fluor Enterprises, a JV**Location:** Job Site

# WELDING INSPECTION REPORT

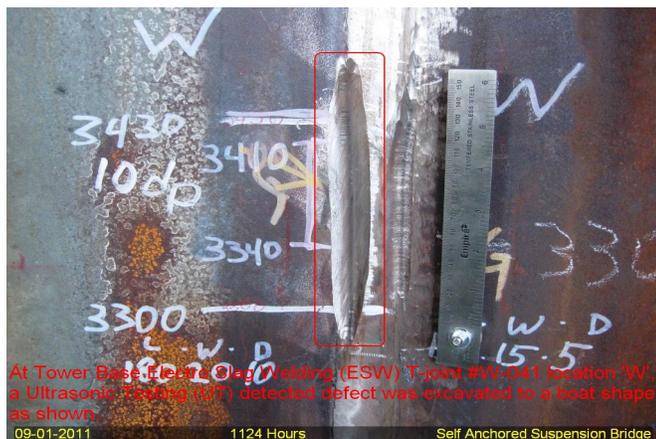
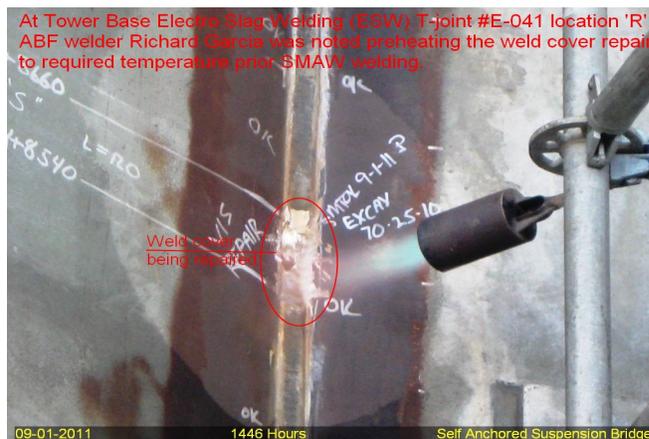
At Tower Base Electro Slag Welding (ESW) T-joints E-041 location 'R' and S-041 location 'S' outside, ABF welder Richard Garcia was noted removing the remnants of the strong back that were used during the ESW. The welder was using carbon air arc gouging to remove the remnants and was followed by disc/flapper grinder to make the surface smooth. After the smooth grinding by the welder, ABF QC John Pagliero was noted performing Magnetic Particle Testing (MT) on the remnants removal. The welder has started from the very top of the ESW and noted moving side to side between the two ESW weld joints moving his way to the bottom. The welder has finished four (4) remnants when he noted there was a visually rejected cover on location 'S' due to weld overlap where he excavated to sound metal and QC MT'd the excavation and welded it afterwards.

At Tower Base Electro Slag Welding (ESW) T-joint #S-041 location 'S' outside, QA randomly ABF welder Richard Garcia perform 3G SMAW welding repair on the visually (VT) detected defect on the surface of the vertical weld of the ESW. The welder was observed welding in the 3G (vertical) position utilizing Shielded Metal Arc Welding (SMAW) with 1/8" diameter E7018H4R electrode implementing welding procedure ABF-WPS-D15-1000-Repair Rev. 2. The repair excavation located at Y=8540mm to Y=8660mm was excavated to dimensions of 70mm long x 25mm wide x 10mm deep. The excavation was tested using Magnetic Particle Testing (MT) by ABF QC John Pagliero and confirmed by this QA. The repair excavation and the adjacent base metal was preheated and maintained to more than 149°C (300°F) using propylene gas torch. During the shift, ABF

At Tower Base Electro Slag Welding (ESW) T-joint #W-041 location 'W' outside, ABF QC Steve Mc Connell was observed performing Magnetic Particle Testing (MT) on the excavated UT detected defect of the ESW welded joint. The result of the MT was positive and was verified by this QA with same result. The boat shape excavation was measured 180mm long x 20mm wide x 10mm deep and according to QC this has been made a Request for Welding Repair (RWR) and awaiting its approval.
