DEPARTMENT OF TRANSPORTATION

Contract #: 04-0120F4Cty: SF/ALA Rte: 80 PM: 13.2/13.9File #: 1.28**WELDING INSPECTION REPORT****Resident Engineer:** Petersen, Brian**Address:** 333 Burma Road**City:** Oakland, CA 94607**Report No:** WIR-026250**Date Inspected:** 08-Sep-2011**Project Name:** SAS Superstructure**OSM Arrival Time:** 700**Prime Contractor:** American Bridge/Fluor Enterprises, a JV**OSM Departure Time:** 1730**Contractor:** American Bridge/Fluor Enterprises, a JV**Location:** Job Site**CWI Name:** Steve Jensen**CWI Present:** Yes No**Inspected CWI report:** Yes No N/A**Rod Oven in Use:** Yes No N/A**Electrode to specification:** Yes No N/A**Weld Procedures Followed:** Yes No N/A**Qualified Welders:** Yes No N/A**Verified Joint Fit-up:** Yes No N/A**Approved Drawings:** Yes No N/A**Approved WPS:** Yes No N/A**Delayed / Cancelled:** Yes No N/A**Bridge No:** 34-0006**Component:** SAS Tower & OBG**Summary of Items Observed:**

A). Tower Shear Plates

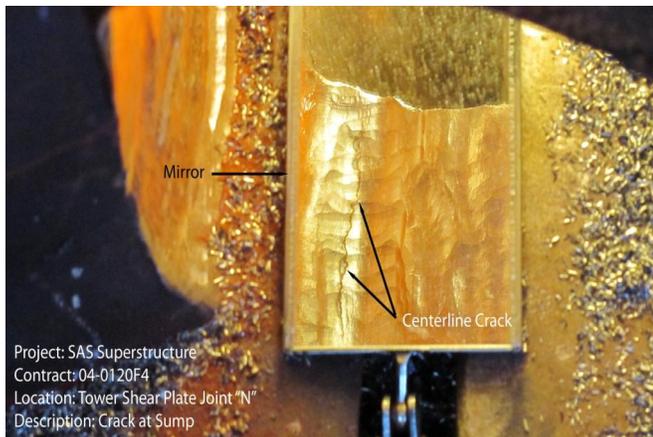
The QAI was also informed by Quality Control Lead Inspector, Bonifacio Daquinag, Jr., in regards to a center line crack discovered by QC inspector John Pagliero at the weld access hole of the lower sump area located at joint "N" and identified as WN: N-041. The crack was discovered during the performance of the Magnetic Particle Testing

(MPT) and at the conclusion of the testing it was noted that approximate depth appeared to be full cross section of the weld. At the completion of the MPT, Mr. Pagliero performed an Ultrasonic Test (UT) to determine the length which was noted at 23 mm.

The digital photograph below illustrate some of the work observed during this scheduled work date.

Later in the shift this QAI was notified by Structures Representative , Doug Wright, that an e-mail was issued by Pat Lowry, Structural Materials Representative (SMR), recommended that the excavations and repair welding be terminated at this time until the Contractor, American Bridge/Fluor JV, submit documentation regarding the reason for the cracking and the non-fusion issues of the Electro-Slag Welding on the tower shear plate to the tower skin plate connections.
