Contract #: 04-0120F4Cty: SF/ALA Rte: 80 PM: 13.2/13.9File #: 1.28**WELDING INSPECTION REPORT**

Report No: WIR-026254
Date Inspected: 02-Sep-2011

Project Name: SAS Superstructure
Prime Contractor: American Bridge/Fluor Enterprises, a JV
Contractor: American Bridge/Fluor Enterprises, a JV

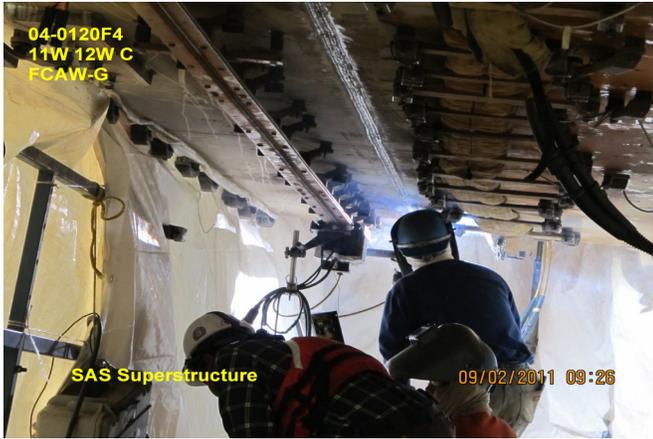
The QA inspector randomly observed ABF welding operator Jin Pei Wang ID#7299 performing Flux Core Arc Welding with gas (FCAW-G) utilizing a “Bug-O” motorized rail system with a magnetic base attached in the 4G overhead position on the underside of side plate C2, at 11W 12W of the OBG. The QA inspector observed the QC inspector identified as Steve Jensen monitoring the welding to ensure the welding parameters were in compliance pertaining to ABF-WPS-D15-3042B-1.

The parameters were recorded as (A=235/V=24/TS=250/HI=1.4). The QA inspector made subsequent observations throughout the shift to monitor quality and noted that the work is in progress and appears to be in general conformance to the contract requirements.
