**DEPARTMENT OF TRANSPORTATION**

Contract #: 04-0120F4Cty: SF/ALA Rte: 80 PM: 13.2/13.9File #: 1.28**WELDING INSPECTION REPORT****Resident Engineer:** Casey, William**Address:** 333 Burma Road**City:** Oakland, CA 94607**Report No:** WIR-026257**Date Inspected:** 09-Sep-2011**Project Name:** SAS Superstructure**OSM Arrival Time:** 700**Prime Contractor:** American Bridge/Fluor Enterprises, a JV**OSM Departure Time:** 1530**Contractor:** American Bridge/Fluor Enterprises, a JV**Location:** Jobsite

**Bridge No:** 34-0006**Summary of Items Observed:**

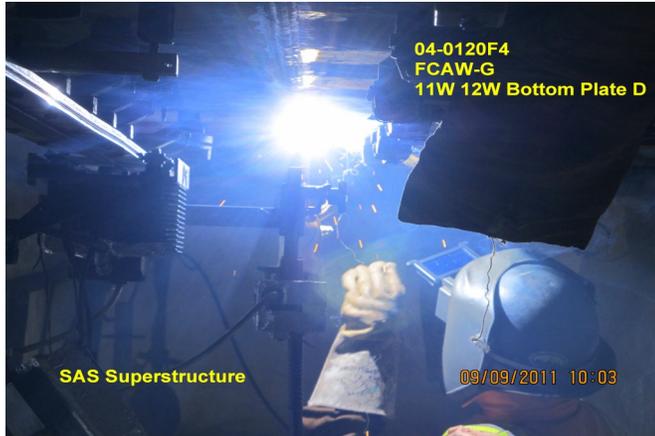
The QA inspector randomly observed ABF welding operator James Zhen ID#6001 performing Flux Core Arc Welding with gas (FCAW-G) utilizing a "Bug-O" motorized rail system with a magnetic base attached in the 4G overhead position on the underside of bottom plate D, at 11W 12W of the OBG. The QA inspector observed the QC inspector identified as Steve Jensen monitoring the welding to ensure the welding parameters were in compliance pertaining to ABF-WPS-D15-3042A-4. The parameters were recorded as (A=250/V=24.4/TS=175/HI=2.09). The QA inspector made subsequent observations throughout the shift to monitor quality and noted that the work is in progress and appears to be in general conformance to the contract requirements.
