DEPARTMENT OF TRANSPORTATION

Contract #: 04-0120F4Cty: SF/ALA Rte: 80 PM: 13.2/13.9File #: 1.28**WELDING INSPECTION REPORT****Resident Engineer:** Casey, William**Address:** 333 Burma Road**City:** Oakland, CA 94607**Report No:** WIR-026258**Date Inspected:** 09-Sep-2011**Project Name:** SAS Superstructure**OSM Arrival Time:** 700**Prime Contractor:** American Bridge/Fluor Enterprises, a JV**OSM Departure Time:** 1530**Contractor:** American Bridge/Fluor Enterprises, a JV**Location:** Job Site

CWI Name:	John Pagliero and Steve Mc Connell			CWI Present:	Yes	No	
Inspected CWI report:	Yes	No	N/A	Rod Oven in Use:	Yes	No	N/A
Electrode to specification:	Yes	No	N/A	Weld Procedures Followed:	Yes	No	N/A
Qualified Welders:	Yes	No	N/A	Verified Joint Fit-up:	Yes	No	N/A
Approved Drawings:	Yes	No	N/A	Approved WPS:	Yes	No	N/A
				Delayed / Cancelled:	Yes	No	N/A
Bridge No:	34-0006			Component:	SAS Tower

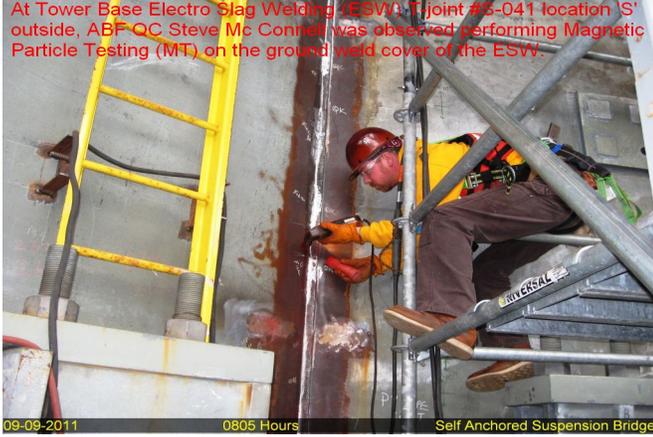
At Tower Base Electro Slag Welding (ESW) T-joint #E-041 location 'S' outside, ABF QC Steve Mc Connell was observed performing Magnetic Particle Testing (MT) on the ground weld cover of the ESW.

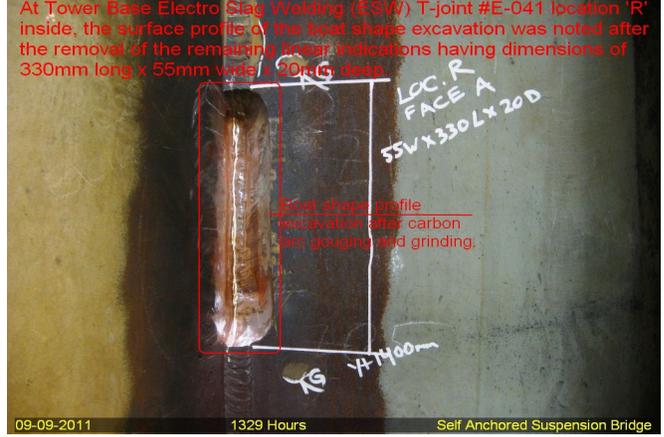
At Tower Base Elevation Electro Slag Welding (ESW) T-joint E-041 location 'R' (inside), QA randomly observed Richard Garcia excavate the opposite side of the visually rejected defect from the outside but has remaining indications after 40mm deep excavation. During the shift, the welder has completely excavated and smooth ground the remaining indications. ABF QC Steve Mc Connell was noted performing MT on the remaining indications with positive results. QA verified the MT performed by QC with same result. The final excavation was located at Y=1400mm and having dimensions of 330mm long x 55mm wide x 20mm deep. Since it was already the end of

At Tower Base Electro Slag Welding (ESW) T-joint #E-041 location 'R' inside, the surface profile of the boat shape excavation was noted after the removal of the remaining linear indications having dimensions of 330mm long x 55mm wide x 20mm deep.

the shift, the welder informed this QA and ABF QC that the welding repair will be done Monday.
