Contract #: 04-0120F4Cty: SF/ALA Rte: 80 PM: 13.2/13.9File #: 1.28**WELDING INSPECTION REPORT**

Report No: WIR-026259
Date Inspected: 08-Sep-2011

Project Name: SAS Superstructure
Prime Contractor: American Bridge/Fluor Enterprises, a JV
Contractor: American Bridge/Fluor Enterprises, a JV

Self Anchored Suspension (SAS) Tower, Electro Slag Welding (ESW):

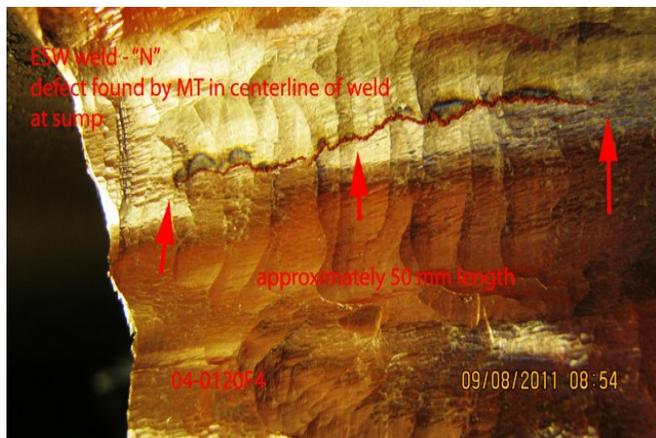
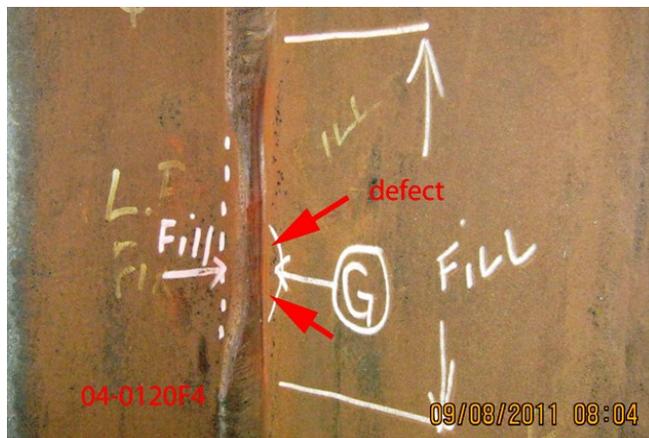
ESW weld location N: This QA Inspector was informed by QC Inspector Steve McConnell that he had observed a 50 mm long defect centered in the 60 mm thick plate originating from the sump of the weld, see photo below. QC Inspector Steve McConnell informed this QA Inspector he observed the defect after performing MT on the sump area. QC Inspector Steve McConnell also informed this QA Inspector he had performed MT on both sides/faces of the weld and the MT indication did not break the edge of the weld. This QA Inspector observed the defect appeared to be on the centerline of the weld. QC Inspector Steve McConnell stated no further grinding/work would be performed at this location at this time and that a photo of the defect would be taken a repair request would be submitted.
