DEPARTMENT OF TRANSPORTATION

Contract #: 04-0120F4Cty: SF/ALA Rte: 80 PM: 13.2/13.9File #: 1.28**WELDING INSPECTION REPORT****Resident Engineer:** Casey, William**Address:** 333 Burma Road**City:** Oakland, CA 94607**Report No:** WIR-026262**Date Inspected:** 12-Sep-2011**Project Name:** SAS Superstructure**OSM Arrival Time:** 700**Prime Contractor:** American Bridge/Fluor Enterprises, a JV**OSM Departure Time:** 1730**Contractor:** American Bridge/Fluor Enterprises, a JV**Location:** Job Site

WELDING INSPECTION REPORT

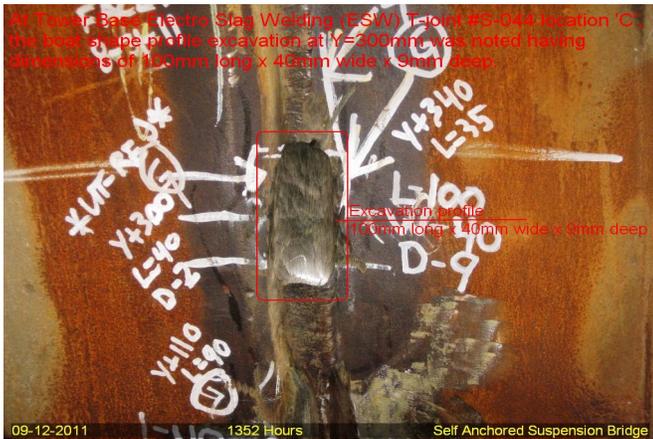
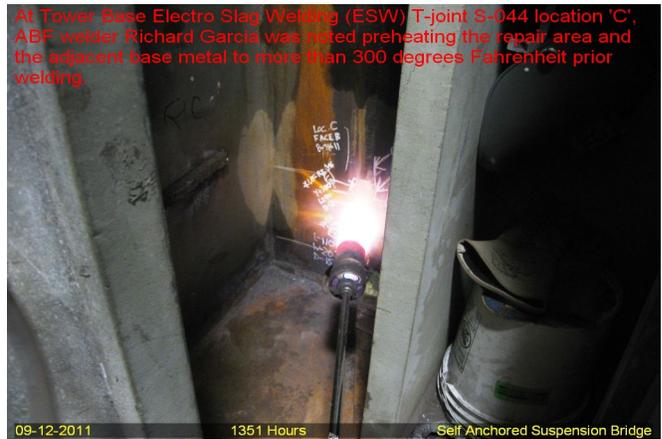
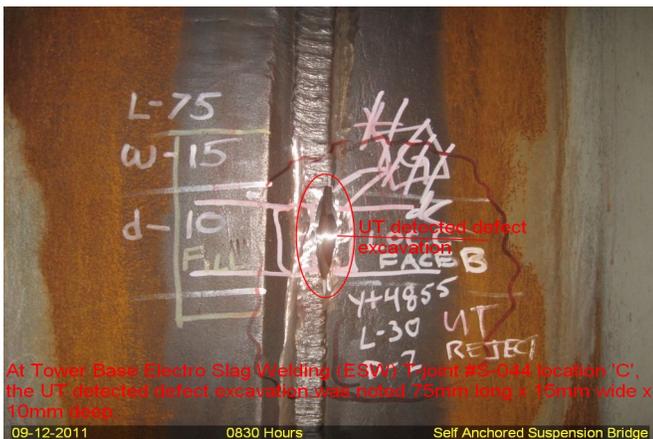
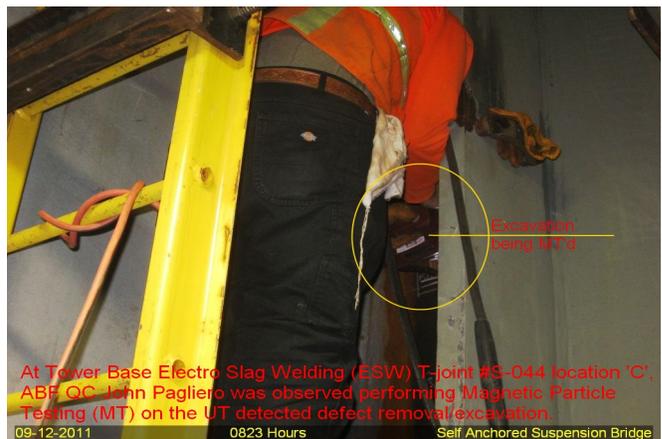
At Tower Base Elevation Electro Slag Welding (ESW) T-joint S-044 location 'C', this QA randomly observed ABF welder Richard Garcia excavate the visually and Ultrasonic Testing (UT) detected defect at ESW welded T-joint using carbon air arc gouging. Prior to the excavation, the welder has preheated the defect location to more than 250°F using the propylene gas torch. During the excavation, the welder has noted linear indications which signified a lack of fusion defect. QC has performed the MT as the welder chase the extent of the indications. The repair excavation was located at Y=4855 and was having a final excavation dimensions of 75mm long x 15mm wide x 10mm deep that was ground smooth. ABF QC John Pagliero was noted performing the visual test (VT) and Magnetic Particle Testing (MT) on the excavation with positive result. This QA performed VT/MT verification on the defect removal and noted same result. After the excavation and testing on the defect removal, QC has informed this QA that this excavation and repair will not require Repair Welding Request (RWR) since it was a minor repair but will be documented thru Weld Repair Report (WRR).

After the completion of the excavation of above mentioned ESW weld repair, this QA randomly ABF welder Richard Garcia perform 3G SMAW first time welding repair (R1) on the Ultrasonic Testing (UT) detected defect on the vertical weld of the ESW. The welder was observed welding in the 3G (vertical) position utilizing Shielded Metal Arc Welding (SMAW) with 1/8" diameter E7018H4R electrode implementing welding procedure ABF-WPS-D15-1000-Repair Rev. 2. The boat shape repair located at Y=4855mm was excavated as mentioned

above. The repair excavation and the adjacent base metal were preheated to more than 300°F using the propylene gas torch. During the shift, ABF QC John Pagliero was noted monitoring the welder. Measured welding parameter during welding was 130 amperes on a 1/8" diameter E7018H4R electrode. During the shift, repair welding was completed and the welder has moved to another UT detected defect location Y=300mm of the same ESW T-joint S-044 location 'C' that was previously excavated and tested.

At Tower Base Elevation Electro Slag Welding (ESW) T-joint S-044 location 'C', this QA randomly ABF welder Richard Garcia perform 3G SMAW welding repair due to UT detected defect. The welder was observed welding in the 3G (vertical) position utilizing Shielded Metal Arc Welding (SMAW) with 1/8" diameter E7018H4R electrode implementing welding procedure ABF-WPS-D15-1000-Repair Rev. 2. The excavation located at Y=300mm and having excavation dimensions of 100mm long x 40mm wide x 9mm deep was previously tested using Magnetic Particle Testing (MT) by ABF QC Steve Mc Connell and randomly verified by this QA with positive result. The repair excavations and the adjacent base metal were preheated to more than 300°F using the propylene gas torch. During the shift, ABF QC John Pagliero was noted monitoring the welder. Measured welding parameter during welding was 130 amperes on a 1/8" diameter E7018H4R electrode. At the end of the shift, repair welding was still continuing and should remain tomorrow.
