DEPARTMENT OF TRANSPORTATION

Contract #: 04-0120F4Cty: SF/ALA Rte: 80 PM: 13.2/13.9File #: 1.28**WELDING INSPECTION REPORT****Resident Engineer:** Casey, William**Address:** 333 Burma Road**City:** Oakland, CA 94607**Report No:** WIR-026267**Date Inspected:** 13-Sep-2011**Project Name:** SAS Superstructure**OSM Arrival Time:** 700**Prime Contractor:** American Bridge/Fluor Enterprises, a JV**OSM Departure Time:** 1530**Contractor:** American Bridge/Fluor Enterprises, a JV**Location:** Jobsite

Bridge No: 34-0006**Summary of Items Observed:**

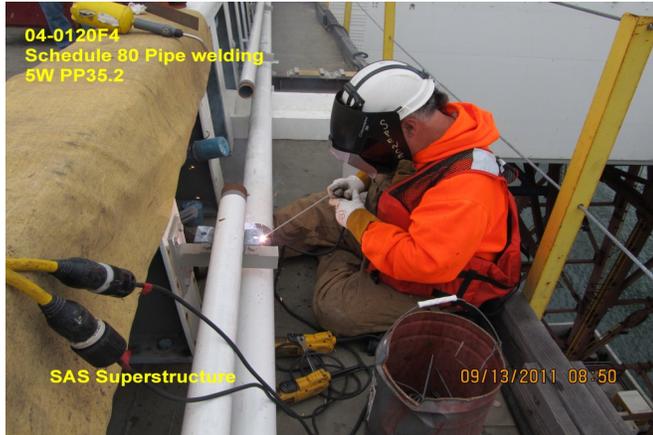
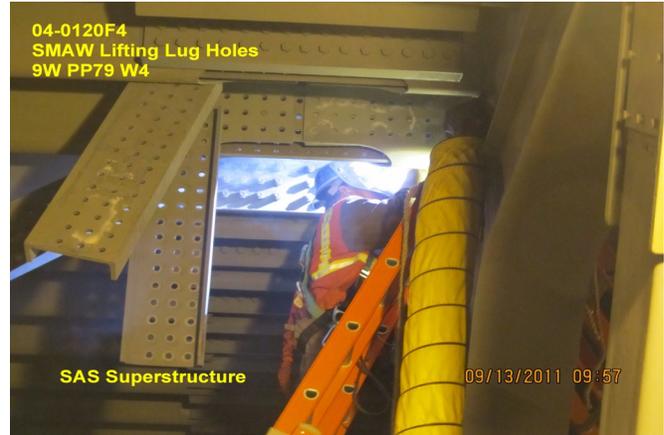
The QA inspector observed F.W. Spencer welder Curtis Jump ID# 7326 performing Shielded Metal Arc Welding (SMAW) in the 1G flat and 3G vertical positions on 2.5 and 4 inch schedule 80 pipe located at 5W PP835.2 weld #19/2.5/35/SW and weld #19/4/35/SW. The QA inspector verified the fit up of the joints and found it to be satisfactory. The QA inspector observed the QC inspector identified as Steve Jensen monitoring the welding to ensure the welding parameters were in compliance pertaining to WPS-1-12-1 Revision 2 (1.12). The welder was observed implementing 6010 electrodes in the root pass with the balance using 7018 electrodes. The QA inspector made subsequent observations throughout the shift to monitor quality and noted that the work appears to be in general conformance with the contract documents.

The QA inspector observed ABF welder Mike Jimenez ID# 4671 performing Shielded Metal Arc Welding (SMAW) in the 4G overhead position on Lifting Lug Holes (LLH) #2 and 4 located at 9W PP79 W4. The QA inspector observed the QC inspector identified as Sal Moreno monitoring the welding to ensure the welding parameters were in compliance pertaining to ABF-WPS-D15-1110A Revision 1. The parameters were recorded as (Amperes=135). The QA inspector made subsequent observations throughout the shift to monitor quality and the QA inspector noted that the work appeared to be in general conformance with the contract documents.
