DEPARTMENT OF TRANSPORTATION

Contract #: 04-0120F4Cty: SF/ALA Rte: 80 PM: 13.2/13.9File #: 1.28**WELDING INSPECTION REPORT****Resident Engineer:** Casey, William**Address:** 333 Burma Road**City:** Oakland, CA 94607**Report No:** WIR-026287**Date Inspected:** 12-Sep-2011**Project Name:** SAS Superstructure**OSM Arrival Time:** 700**Prime Contractor:** American Bridge/Fluor Enterprises, a JV**OSM Departure Time:** 1530**Contractor:** American Bridge/Fluor Enterprises, a JV**Location:** Job Site**CWI Name:** Jesus Cayabyab**CWI Present:** Yes No**Inspected CWI report:** Yes No N/A**Rod Oven in Use:** Yes No N/A**Electrode to specification:** Yes No N/A**Weld Procedures Followed:** Yes No N/A**Qualified Welders:** Yes No N/A**Verified Joint Fit-up:** Yes No N/A**Approved Drawings:** Yes No N/A**Approved WPS:** Yes No N/A**Delayed / Cancelled:** Yes No N/A**Bridge No:** 34-0006**Component:** OBG Sections**Summary of Items Observed:**

Self Anchored Suspension (SAS) Tower, Electro Slag Welding (ESW):

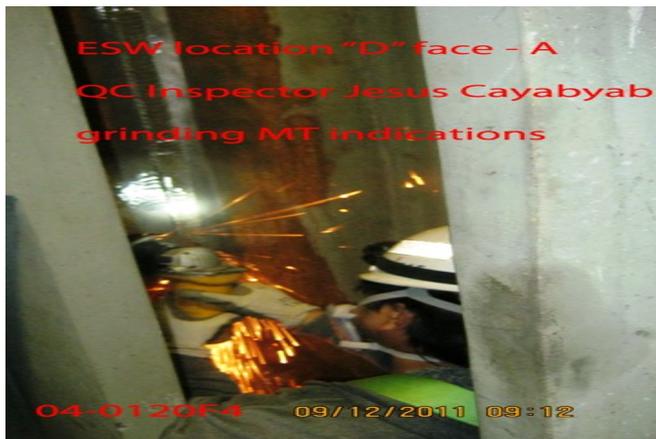
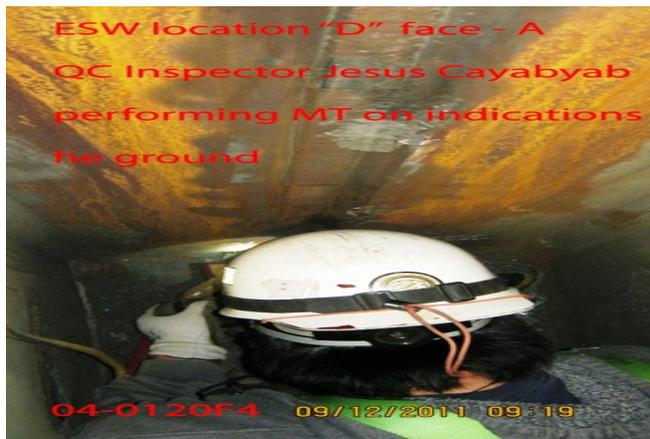
ESW weld location D -face A: This QA Inspector observed that after QC Inspector Jesus Cayabyab performed the verification of the welding parameters noted above he proceeded to start grinding MT indication at this ESW weld location, between the 3-meter and 9-meter elevations. This QA Inspector observed after performing the grinding QC Inspector Jesus Cayabyab performed MT to verify the defect was removed or to continue grinding to remove the defect. See photos below.
