**DEPARTMENT OF TRANSPORTATION**

Contract #: 04-0120F4Cty: SF/ALA Rte: 80 PM: 13.2/13.9File #: 1.28**WELDING INSPECTION REPORT****Resident Engineer:** Casey, William**Address:** 333 Burma Road**City:** Oakland, CA 94607**Report No:** WIR-026315**Date Inspected:** 19-Sep-2011**Project Name:** SAS Superstructure**OSM Arrival Time:** 700**Prime Contractor:** American Bridge/Fluor Enterprises, a JV**OSM Departure Time:** 1730**Contractor:** American Bridge/Fluor Enterprises, a JV**Location:** Job Site**CWI Name:** See Below**CWI Present:** Yes No**Inspected CWI report:** Yes No N/A**Rod Oven in Use:** Yes No N/A**Electrode to specification:** Yes No N/A**Weld Procedures Followed:** Yes No N/A**Qualified Welders:** Yes No N/A**Verified Joint Fit-up:** Yes No N/A**Approved Drawings:** Yes No N/A**Approved WPS:** Yes No N/A**Delayed / Cancelled:** Yes No N/A**Bridge No:** 34-0006**Component:** Tower**Summary of Items Observed:**

# WELDING INSPECTION REPORT

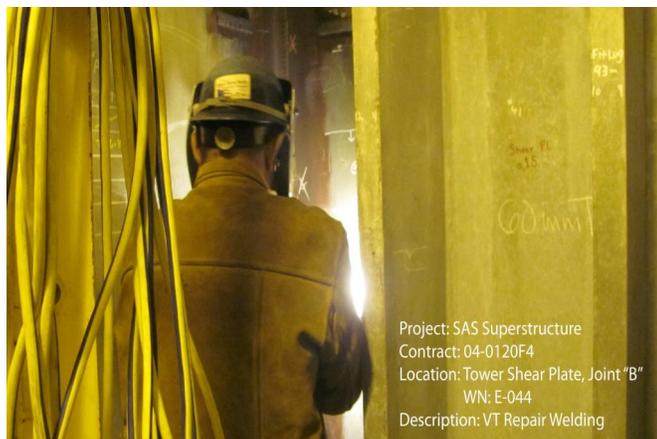
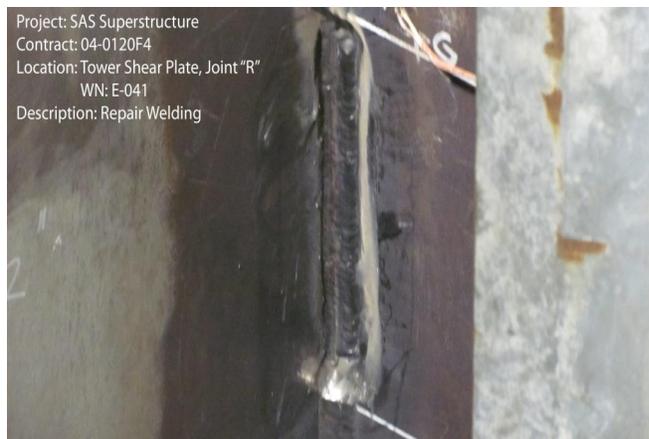
This QAI observed the repair welding of the Electro-Slag Weld (ESW) located at the joint "R" and identified as E-041. The repair welding was performed on the A-Side of the weld joint and the dimensions of the excavation was measured by the QC inspector John Pagliero and noted as 55 mm wide x 330 mm long x 20 mm deep with the Y axis noted as 1400 mm. The welding was performed by Richard Garcia ID-5892 utilizing the Shielded Metal Arc Welding (SMAW) process as per the Welding Procedure Specification (WPS) ABF-WPS-D15-1000 Repair, Rev. 2. The WPS was also used by Mr. Pagliero as a reference during the monitoring of the welding and verifying the welding parameters. The welding parameters were noted by the QC inspector as 132 amps and the minimum preheat temperature of 204 degrees Celsius and the maximum interpass temperature of 230 degrees Celsius appeared to comply with the contract specifications. It was also noted by the QAI that a verbal approval was issued by Construction Representative, Doug Wright, but it appears that ABF/Fluor, JV Welding Quality Control Manager (WQCM) Jim Bowers has not issued or submitted a Request for Weld Repair Approval (RWR). The welding of this repair was not completed during this shift.

This QAI also observed the repair welding and grinding at the following locations; joint "B" and "C", identified accordingly as WN: E-044 and WN: S-044 and joint "A", identified accordingly as WN: N-044. The welding was performed by Rory Hogan ID-3186 and Jeremy Dolman ID-5042. The welding and grinding were not completed

The digital photographs below illustrate some of the work observed during this scheduled work date.
