DEPARTMENT OF TRANSPORTATION

Contract #: 04-0120F4Cty: SF/ALA Rte: 80 PM: 13.2/13.9File #: 1.28**WELDING INSPECTION REPORT****Resident Engineer:** Casey, William**Address:** 333 Burma Road**City:** Oakland, CA 94607**Report No:** WIR-026316**Date Inspected:** 20-Sep-2011**Project Name:** SAS Superstructure**OSM Arrival Time:** 700**Prime Contractor:** American Bridge/Fluor Enterprises, a JV**OSM Departure Time:** 1730**Contractor:** American Bridge/Fluor Enterprises, a JV**Location:** Job Site

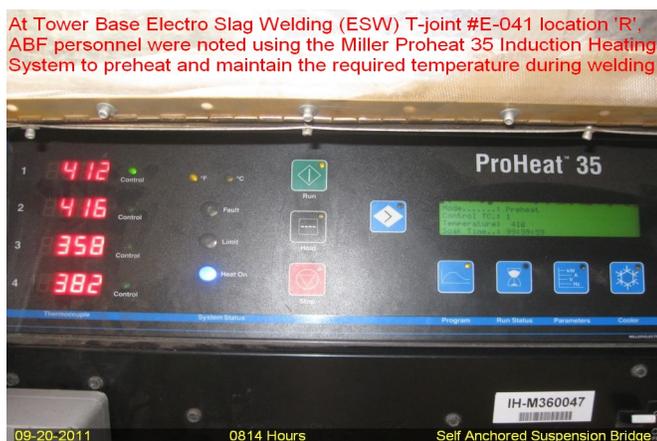
At Tower Base Elevation Electro Slag Welding (ESW) T-joint E-041 location 'R', QA randomly ABF welder Richard Garcia continuing to perform 3G SMAW first time welding repair (R1) on the visually (VT) detected defect on the surface of the vertical weld of the ESW. The welder was observed welding in the 3G (vertical) position utilizing Shielded Metal Arc Welding (SMAW) with 1/8" diameter E7018H4R electrode implementing welding procedure ABF-WPS-D15-1000-Repair Rev. 2. The boat shape repair excavation located at Y=1400mm to Y=1730mm was excavated to dimensions of 330mm long x 55mm wide x 20mm deep. The excavation was previously tested using Magnetic Particle Testing (MT) by ABF QC Steve Mc Connell and this QA with positive result. The new excavation is located at the opposite side of the excavation that was repaired from the outside of the weld joint. The repair excavation and the adjacent base metal was preheated and maintained to more than 204°C (400°F) using Miller Proheat Induction Heating System with the heater blankets placed at the other side of the repair. During the shift, ABF QC John Pagliero was noted monitoring the welder. Measured welding parameter during welding was 135 amperes on a 1/8" diameter E7018H4R electrode. At the end of the shift, repair welding was still continuing and should remain tomorrow. The welder has held the 400°F preheat by programming the Miller Proheat 35 Induction Heating System to hold the preheat of 400°F for three hours and cool down at 150°F per hour as recommended by ABF.

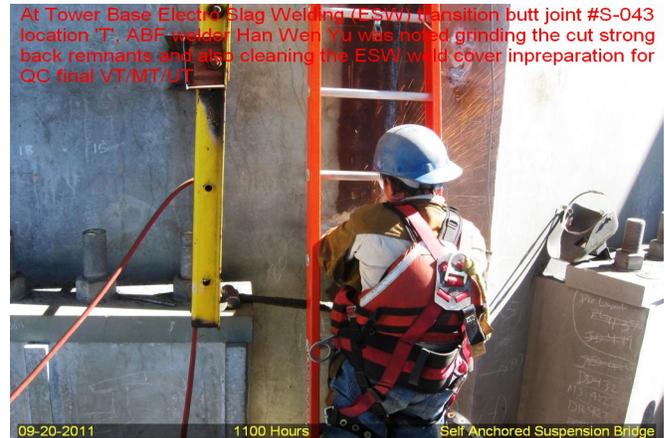
ESW location 'Q', 'P' and 'T' (outside) – ABF welders Xiao Jian Wan, Jin Pei Wang and Han Wen Yu were noted continuing to grind the weld cover of the welded ESW in preparation for the QC VT/MT. It includes also the grinding of the cut remnants of the strong back that were used during the ESW. At the end of the shift, grinding of the weld cover and strong back remnants was still continuing.
