**DEPARTMENT OF TRANSPORTATION**

Contract #: 04-0120F4Cty: SF/ALA Rte: 80 PM: 13.2/13.9File #: 1.28**WELDING INSPECTION REPORT****Resident Engineer:** Casey, William**Address:** 333 Burma Road**City:** Oakland, CA 94607**Report No:** WIR-026326**Date Inspected:** 21-Sep-2011**Project Name:** SAS Superstructure**OSM Arrival Time:** 700**Prime Contractor:** American Bridge/Fluor Enterprises, a JV**OSM Departure Time:** 1730**Contractor:** American Bridge/Fluor Enterprises, a JV**Location:** Job Site

# WELDING INSPECTION REPORT

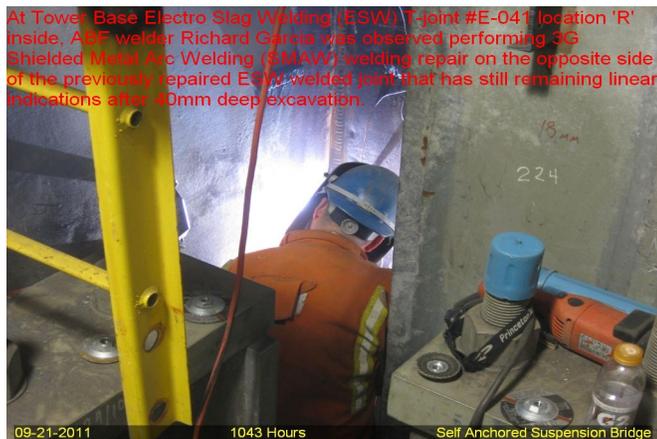
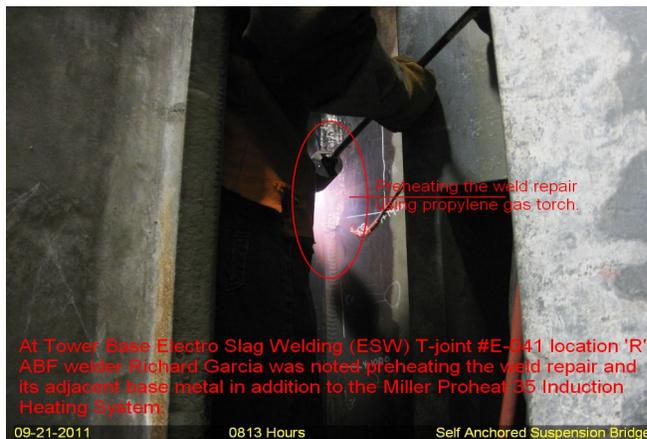
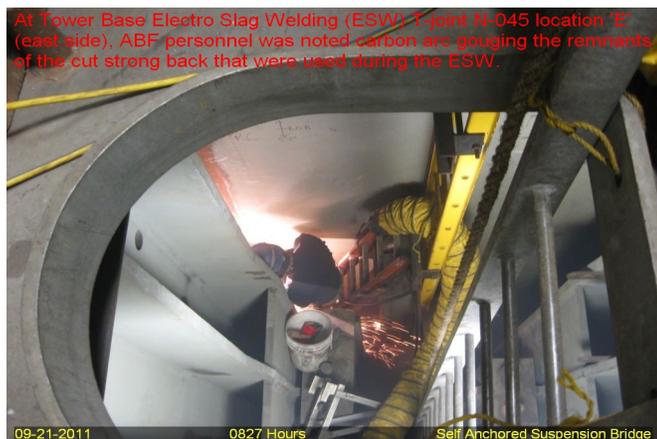
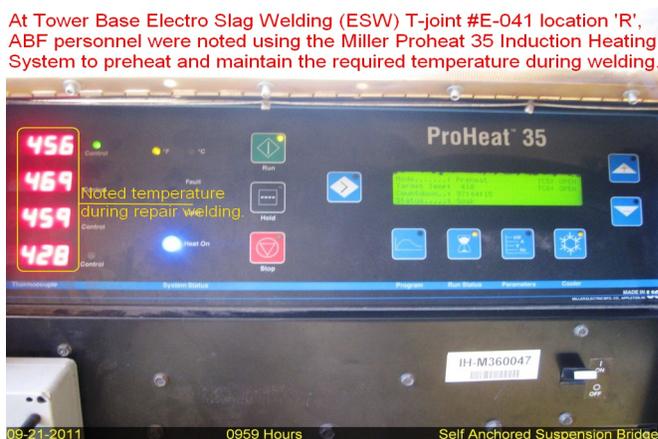
At Tower Base Elevation Electro Slag Welding (ESW) T-joint E-041 location 'R', QA randomly ABF welder Richard Garcia continuing to perform 3G SMAW first time welding repair (R1) on the visually (VT) detected defect on the surface of the vertical weld of the ESW. The welder was observed welding in the 3G (vertical) position utilizing Shielded Metal Arc Welding (SMAW) with 1/8" diameter E7018H4R electrode implementing welding procedure ABF-WPS-D15-1000-Repair Rev. 2. The boat shape repair excavation located at Y=1400mm to Y=1730mm was excavated to dimensions of 330mm long x 55mm wide x 20mm deep. The excavation was previously tested using Magnetic Particle Testing (MT) by ABF QC Steve Mc Connell and this QA with positive result. The new excavation is located at the opposite side of the excavation that was repaired from the outside of the weld joint. The repair excavation and the adjacent base metal was preheated and maintained to more than 204°C (400°F) using Miller Proheat Induction Heating System with the heater blankets placed at the other side of the repair. During the shift, ABF QC John Pagliero was noted monitoring the welder. Measured welding parameter during welding was 135 amperes on a 1/8" diameter E7018H4R electrode. At the end of the shift, repair welding was completed and the welder has held the 400°F preheat by programming the Miller Proheat 35 Induction Heating System to hold the preheat of 400°F for three hours and cool down at 150°F per hour as recommended by ABF.

welder Jeremy Dolman continuing to perform 3G SMAW cover welding repair due to excessive grinding on the visually noted overlap. The welder was observed welding in the 3G (vertical) position utilizing Shielded Metal Arc Welding (SMAW) with 1/8" diameter E7018H4R electrode implementing welding procedure ABF-WPS-D15-1000-Repair Rev. 2. The excavation was previously tested using Magnetic Particle Testing (MT) by ABF QC Steve Mc Connell and randomly verified by this QA with positive result. The repair excavation and the adjacent base metal were preheated to more than 300°F using the propylene gas torch. During the shift, ABF QC John Pagliero was noted monitoring the welder. Measured welding parameter during welding was 115 amperes on a 1/8" diameter E7018H4R electrode. At the end of the shift, repair welding was still continuing and should remain tomorrow.

At Tower Base Elevation Electro Slag Welding (ESW) T-joint E-044 location 'B' (south side), QA randomly ABF welder Rory Hogan continuing to perform 3G SMAW cover welding repair due to excessive grinding on the visually noted overlap. The welder was observed welding in the 3G (vertical) position utilizing Shielded Metal Arc Welding (SMAW) with 1/8" diameter E7018H4R electrode implementing welding procedure ABF-WPS-D15-1000-Repair Rev. 2. The excavations were previously tested using Magnetic Particle Testing (MT) by ABF QC Steve Mc Connell and randomly verified by this QA with positive result. The repair excavations and the adjacent base metal were preheated to more than 300°F using the propylene gas torch. During the shift, ABF QC John Pagliero was noted monitoring the welder. Measured welding parameter during welding was 130 amperes on a 1/8" diameter E7018H4R electrode. At the end of the shift, repair welding was still continuing and should remain tomorrow.
