DEPARTMENT OF TRANSPORTATION

Contract #: 04-0120F4Cty: SF/ALA Rte: 80 PM: 13.2/13.9File #: 1.28**WELDING INSPECTION REPORT****Resident Engineer:** Casey, William**Address:** 333 Burma Road**City:** Oakland, CA 94607**Report No:** WIR-026329**Date Inspected:** 20-Sep-2011**Project Name:** SAS Superstructure**OSM Arrival Time:** 700**Prime Contractor:** American Bridge/Fluor Enterprises, a JV**OSM Departure Time:** 1730**Contractor:** American Bridge/Fluor Enterprises, a JV**Location:** Job Site**CWI Name:** See Below**CWI Present:** Yes No**Inspected CWI report:** Yes No N/A**Rod Oven in Use:** Yes No N/A**Electrode to specification:** Yes No N/A**Weld Procedures Followed:** Yes No N/A**Qualified Welders:** Yes No N/A**Verified Joint Fit-up:** Yes No N/A**Approved Drawings:** Yes No N/A**Approved WPS:** Yes No N/A**Delayed / Cancelled:** Yes No N/A**Bridge No:** 34-0006**Component:** Tower**Summary of Items Observed:**

WELDING INSPECTION REPORT

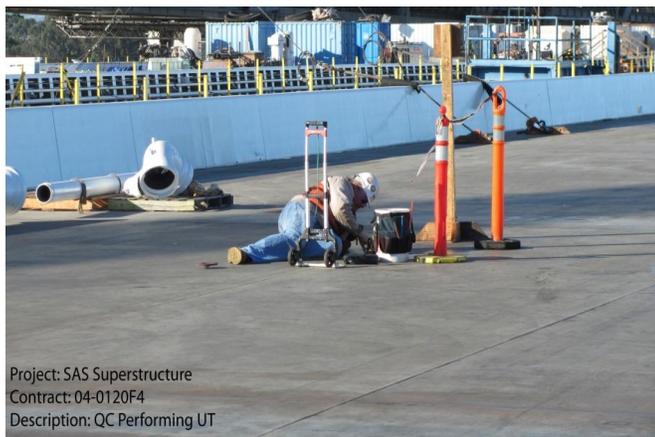
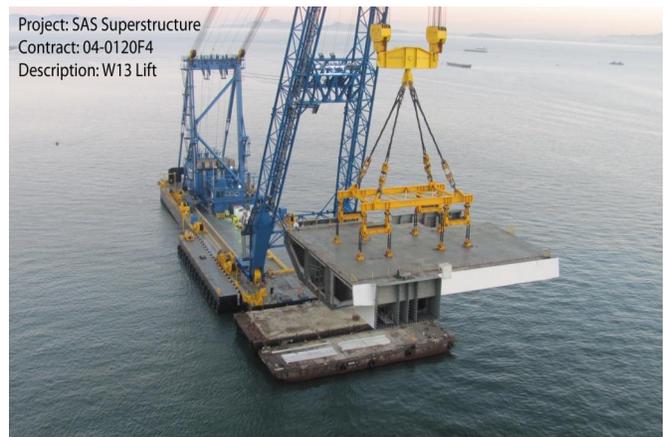
The digital photographs below illustrate some of the work observed during this scheduled work date.
