DEPARTMENT OF TRANSPORTATION

Contract #: 04-0120F4Cty: SF/ALA Rte: 80 PM: 13.2/13.9File #: 1.28**WELDING INSPECTION REPORT**

Report No: WIR-026391
Date Inspected: 22-Sep-2011

Project Name: SAS Superstructure
Prime Contractor: American Bridge/Fluor Enterprises, a JV
Contractor: American Bridge/Fluor Enterprises, a JV

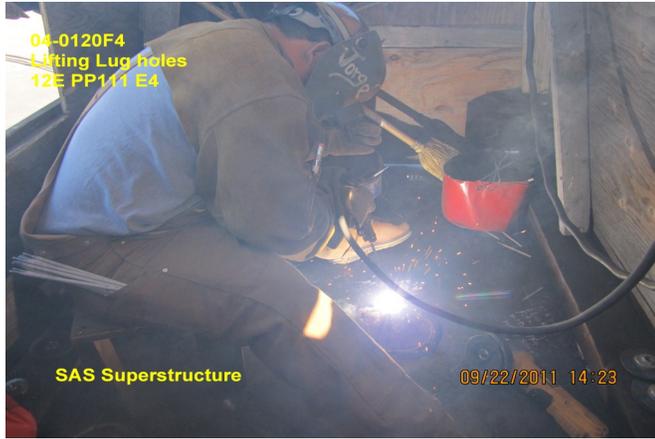
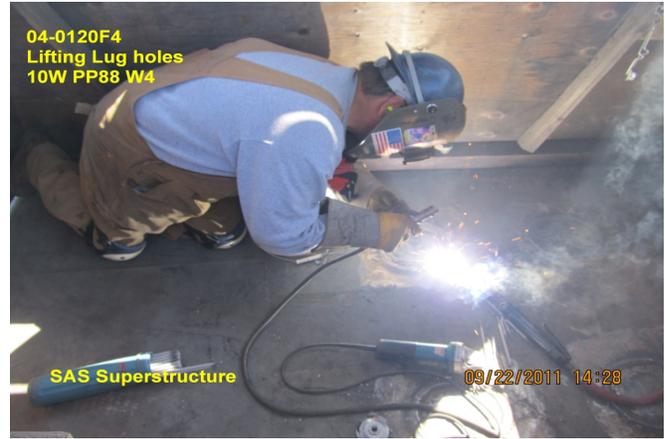
The QA inspector observed ABF welder Mike Jimenez ID# 4671 performing Shielded Metal Arc Welding (SMAW) in the 1G flat position on Lifting Lug Hole (LLH) #2 located at 10W PP88 W4. The QA inspector verified the fit up of the joint and found it to be satisfactory. The QA inspector observed the QC inspector identified as Sal Moreno monitoring the progress to ensure the welding parameters were in compliance pertaining to ABF-WPS-D15-1050A-CU.

The QA inspector observed ABF welder Jorge Lopez ID# 6149 performing Shielded Metal Arc Welding (SMAW) in the 1G flat position on Lifting Lug Hole (LLH) #4 located at 12E PP111 E4. The QA inspector verified the fit up of the joint and found it to be satisfactory. The QA inspector observed the QC inspector identified as Fred Von Hoff monitoring the progress to ensure the welding parameters were in compliance pertaining to ABF-WPS-D15-1050A-CU.

The QA Inspector noted the dimensions of the indications at D1 y+615 as 125mm's in length, and 8mm's depth, y+725 as 180mm's in length and 12mm's in depth, y+1195 as 100mm's in length and 13mm's depth, y+1445 100mm's in length and 6 mm's deep. D2 y+2515 100mm's in length, 10mm's deep, y+2615 180mm's in length, 25 mm's deep, y+3045 90mm's in length and 6mm's deep. The QA Inspector observed the QC Inspector identified as Jesse Cayabyab perform Magnetic Particle inspection on the excavations and found them to be free of indications. The QA inspector verified that the proper procedure was utilized as well as correct technique. The QA inspector observed ABF welder Wai Kit Lai ID#2953 perform Shielded Metal Arc Welding (SMAW) in the 1G flat position with the QC Inspector being present in order to monitor the welding and ensure the welding parameters were in compliance pertaining to ABF-WPS-D15-1001-R. The QA Inspector noted that the work was completed on this date and appeared to be in general conformance with the contract documents.

The QA inspector observed ABF welder Mike Jimenez ID# 4671 performing Shielded Metal Arc Welding (SMAW) in the 1G flat position on Lifting Lug Hole (LLH) #4 located at 10W PP88 W4. The QA inspector verified the fit up of the joint and found it to be satisfactory. The QA inspector observed the QC inspector identified as Sal Moreno monitoring the progress to ensure the welding parameters were in compliance pertaining to ABF-WPS-D15-1050A-CU.
