DEPARTMENT OF TRANSPORTATION

Contract #: 04-0120F4Cty: SF/ALA Rte: 80 PM: 13.2/13.9File #: 1.28**WELDING INSPECTION REPORT****Resident Engineer:** Casey, William**Address:** 333 Burma Road**City:** Oakland, CA 94607**Report No:** WIR-026399**Date Inspected:** 26-Sep-2011**Project Name:** SAS Superstructure**OSM Arrival Time:** 700**Prime Contractor:** American Bridge/Fluor Enterprises, a JV**OSM Departure Time:** 1530**Contractor:** American Bridge/Fluor Enterprises, a JV**Location:** Jobsite

Bridge No: 34-0006**Component:** SAS OBG**Summary of Items Observed:**

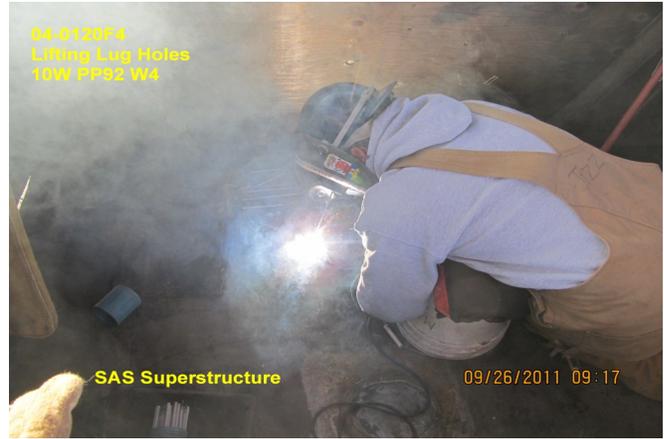
The QA inspector observed ABF welder Mike Jimenez ID# 4671 performing Shielded Metal Arc Welding (SMAW) in the 1G flat position on Lifting Lug Hole (LLH) #4 located at 10W PP92 W4. The QA inspector verified the fit up of the joint and found it to be satisfactory. The QA inspector observed the QC inspector identified as Sal Moreno monitoring the progress to ensure the welding parameters were in compliance pertaining to ABF-WPS-D15-1050A-CU.

The QA inspector made subsequent observations throughout the shift to monitor quality and the QA inspector noted that the work was in progress and appeared to be in general conformance with the contract documents.
