**DEPARTMENT OF TRANSPORTATION**

Contract #: 04-0120F4Cty: SF/ALA Rte: 80 PM: 13.2/13.9File #: 1.28**WELDING INSPECTION REPORT****Resident Engineer:** Casey, William**Address:** 333 Burma Road**City:** Oakland, CA 94607**Report No:** WIR-026426**Date Inspected:** 28-Sep-2011**Project Name:** SAS Superstructure**OSM Arrival Time:** 700**Prime Contractor:** American Bridge/Fluor Enterprises, a JV**OSM Departure Time:** 1730**Contractor:** American Bridge/Fluor Enterprises, a JV**Location:** Job Site

# WELDING INSPECTION REPORT

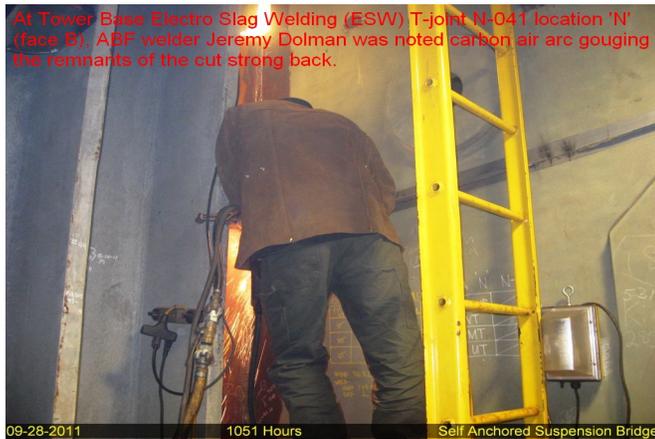
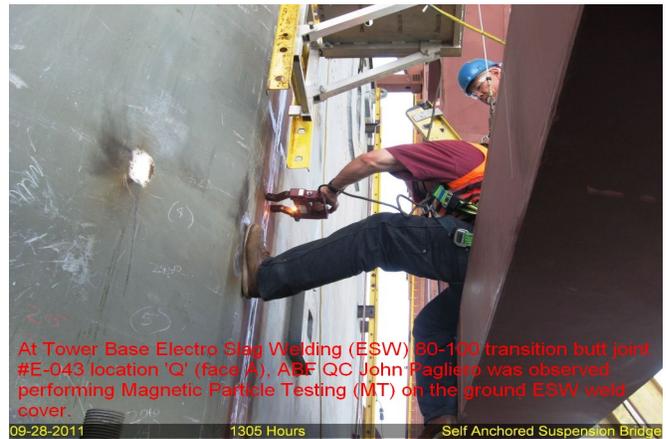
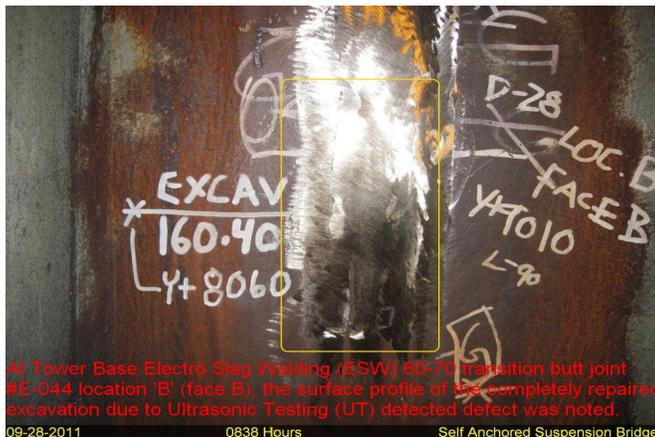
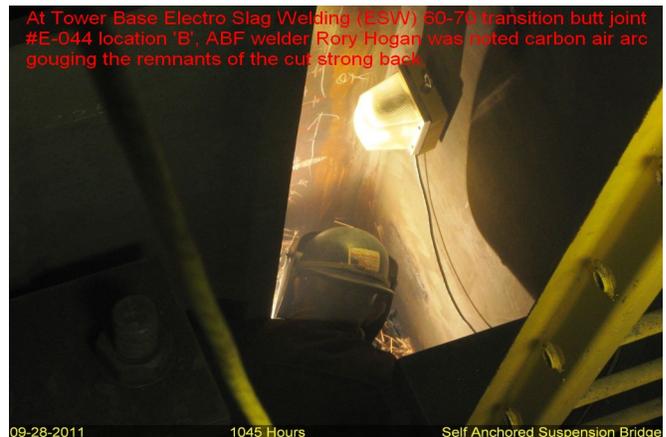
At Tower Base Electro Slag Welding (ESW) T-joint #E-041 location 'R', QA randomly observed ABF welder Richard Garcia perform 2F Shielded Metal Arc Welding (SMAW) fillet welding the two corners of the cut radius to the base plate. The welder was noted fillet in horizontal position using 1/8" diameter E7018H4R electrode. Prior welding, the joint and the adjacent weld metal were preheated to 300°F using propylene gas torch. ABF QC John Pagliero was noted monitoring the parameters of the welder during welding. Measured amperage during welding was 135 amperes on a 1/8" diameter E7018H4R electrode. At the end of the shift, the two welded fillet welds measuring 15mm to 20mm were completed.

At Tower Base Electro Slag Welding (ESW) T-joint #N-041 location 'N' (inside), ABF welder Jeremy Dolman was noted excavating the Ultrasonic Testing (UT) detected defect at Y=9350mm. The welder was using carbon air arc gouging to excavate the defect then followed by die grinder to make the boat shape excavation smooth. The final dimensions of the excavation after carbon arcing/grinding were 210mm long x 22mm wide x 12mm deep. ABF QC William Sherwood was observed performing Magnetic Particle Testing (MT) on the removal of the defect with positive result. This QA also performed verification on the defect removal with same result. After the completion of the excavation, the welder has performed carbon air arc gouging on the remnants of the cut strong back until the end of the shift.

1. ESW location 'G', 'H', 'M' & 'L' (inside inner west diaphragm 9 to 13 meters elevation) – grinding of the ESW weld cover that was marked by QC during their previous VT/MT. Still in progress.
2. ESW locations 'E', 'F', 'G' & 'H' (inside center diaphragm 0 to 9 meters elevation) – grinding of the ESW weld cover that was marked by QC during their previous VT/MT. Still in progress.
3. ESW locations 'P', 'Q', 'V' & 'T' (outside/80-100 butt joint transition) – four ABF welders were noted continuing to grind/clean the ESW weld cover that include removal of strong back remnants.
