**DEPARTMENT OF TRANSPORTATION**

Contract #: 04-0120F4Cty: SF/ALA Rte: 80 PM: 13.2/13.9File #: 1.28**WELDING INSPECTION REPORT**

**Report No:** WIR-026465  
**Date Inspected:** 03-Oct-2011

**Project Name:** SAS Superstructure  
**Prime Contractor:** American Bridge/Fluor Enterprises, a JV  
**Contractor:** American Bridge/Fluor Enterprises, a JV

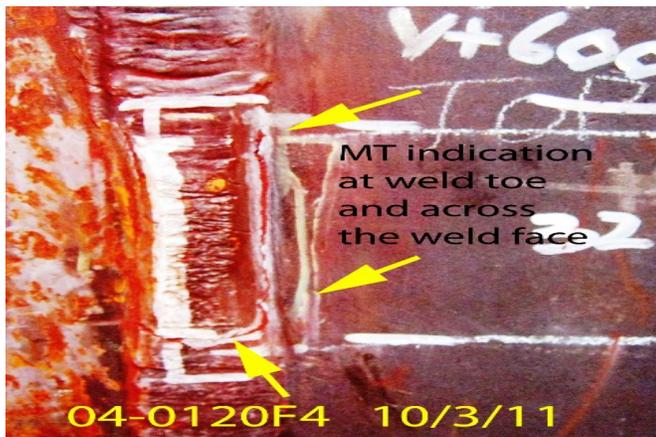
ESW weld joint location R: This QA Inspector performed a random visual verification at the “cold start” area to verify the status of the work at this location and observed what appeared to be a visual defect. This QA Inspector performed Magnetic Particle Testing (MT) from approximately Y-500 to Y-750 and observed an indication approximately 110 mm in length in the toe of the weld on the tower side . This QA Inspector observed this indication appeared to turn and travel in a direction transverse to the weld for approximately 20 mm. Please see photo below. This QA Inspector informed Lead QA Inspector Danny Reyes of this observation and was informed a transverse and/or any MT indications had not been previously reported by QA personnel and/or QC personnel to the best of his Knowledge.
