**DEPARTMENT OF TRANSPORTATION**

Contract #: 04-0120F4Cty: SF/ALA Rte: 80 PM: 13.2/13.9File #: 1.28**WELDING INSPECTION REPORT****Resident Engineer:** Casey, William**Address:** 333 Burma Road**City:** Oakland, CA 94607**Report No:** WIR-026466**Date Inspected:** 30-Sep-2011**Project Name:** SAS Superstructure**OSM Arrival Time:** 700**Prime Contractor:** American Bridge/Fluor Enterprises, a JV**OSM Departure Time:** 1530**Contractor:** American Bridge/Fluor Enterprises, a JV**Location:** Job Site**CWI Name:** See Below**CWI Present:** Yes No**Inspected CWI report:** Yes No N/A**Rod Oven in Use:** Yes No N/A**Electrode to specification:** Yes No N/A**Weld Procedures Followed:** Yes No N/A**Qualified Welders:** Yes No N/A**Verified Joint Fit-up:** Yes No N/A**Approved Drawings:** Yes No N/A**Approved WPS:** Yes No N/A**Delayed / Cancelled:** Yes No N/A**Bridge No:** 34-0006**Component:** Tower & OBG**Summary of Items Observed:**

## WELDING INSPECTION REPORT

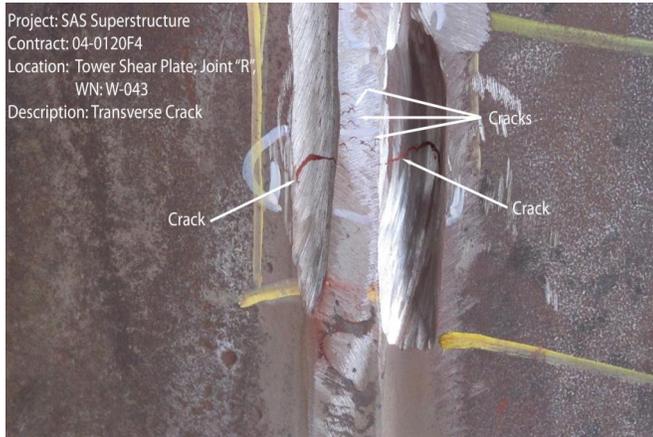
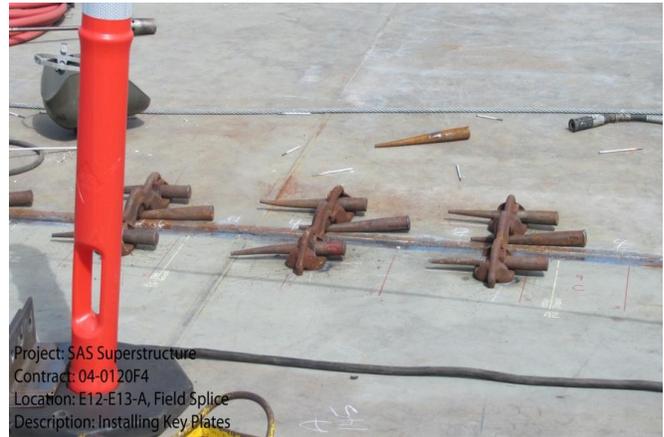
The welding was performed in the vertical position utilizing the E7018-H4R. The 3.2 mm H4R electrodes were stored in a electrically heated, thermostatically controlled oven after the removal from the sealed containers. The exposure limits of the electrodes appeared to comply with the minimum storage oven temperature of 120 degrees Celsius as per the contract documents. The welding parameters and surface temperatures were verified by the QC inspector's utilizing a Fluke 337 clamp meter to measure the electrical welding parameters and Tempil Heat Indicators for verifying the preheat and interpass temperatures. At the time of the observation no issues were

noted by the QAI.
