**DEPARTMENT OF TRANSPORTATION**

Contract #: 04-0120F4Cty: SF/ALA Rte: 80 PM: 13.2/13.9File #: 1.28**WELDING INSPECTION REPORT****Resident Engineer:** Casey, William**Address:** 333 Burma Road**City:** Oakland, CA 94607**Report No:** WIR-026471**Date Inspected:** 06-Oct-2011**Project Name:** SAS Superstructure**OSM Arrival Time:** 700**Prime Contractor:** American Bridge/Fluor Enterprises, a JV**OSM Departure Time:** 1730**Contractor:** American Bridge/Fluor Enterprises, a JV**Location:** Job Site**CWI Name:** As noted below.**CWI Present:** Yes No**Inspected CWI report:** Yes No N/A**Rod Oven in Use:** Yes No N/A**Electrode to specification:** Yes No N/A**Weld Procedures Followed:** Yes No N/A**Qualified Welders:** Yes No N/A**Verified Joint Fit-up:** Yes No N/A**Approved Drawings:** Yes No N/A**Approved WPS:** Yes No N/A**Delayed / Cancelled:** Yes No N/A**Bridge No:** 34-0006**Component:** OBG Components**Summary of Items Observed:**

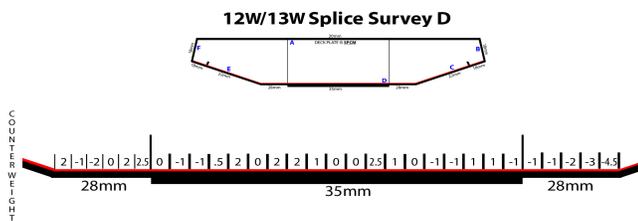
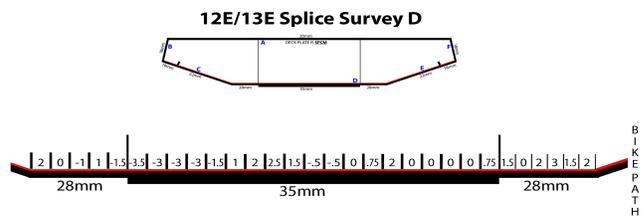
This QA performed a planar alignment survey of the 12E/13E "D" bottom plate butt joint (B-U2-S). Off-set measurements were taken with the Bridge Cam Gauge placed on the 12E portion of the connection.

All measurements were taken as close as possible to the area directly centered between the adjacent open ribs. Please see attached sketches for details of surveys on 12E/13E and 12W/13.
