DEPARTMENT OF TRANSPORTATION

Quality Assurance and Source Inspection

Contract #: 04-0120F4Cty: SF/ALA Rte: 80 PM: 13.2/13.9File #: 1.28**WELDING INSPECTION REPORT****Resident Engineer:** Casey, William**Address:** 333 Burma Road**City:** Oakland, CA 94607**Report No:** WIR-026475**Date Inspected:** 06-Oct-2011**Project Name:** SAS Superstructure**OSM Arrival Time:** 700**Prime Contractor:** American Bridge/Fluor Enterprises, a JV**OSM Departure Time:** 1730**Contractor:** American Bridge/Fluor Enterprises, a JV**Location:** Job Site**CWI Name:** John Pagliero**CWI Present:** Yes No**Inspected CWI report:** Yes No N/A**Rod Oven in Use:** Yes No N/A**Electrode to specification:** Yes No N/A**Weld Procedures Followed:** Yes No N/A**Qualified Welders:** Yes No N/A**Verified Joint Fit-up:** Yes No N/A**Approved Drawings:** Yes No N/A**Approved WPS:** Yes No N/A**Delayed / Cancelled:** Yes No N/A**Bridge No:** 34-0006**Component:** SAS Tower**Summary of Items Observed:**

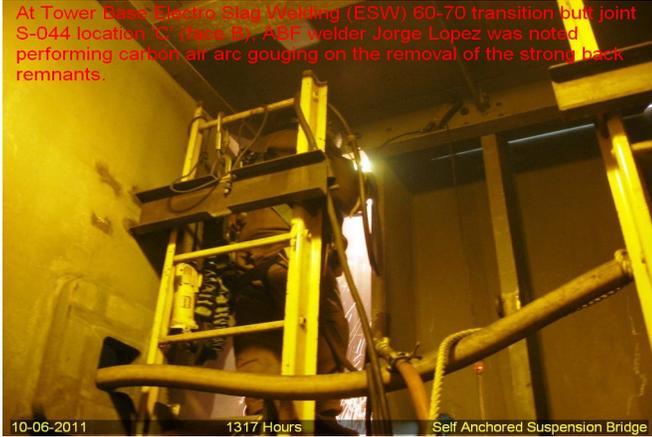
At Tower Base Electro Slag Welding (ESW) 60-70 transition butt joint #S-044 location 'C' (face B), ABF welders Rory Hogan and Jorge Lopez were noted removing the remnants of the temporary strong back attachments. The welders were using carbon air arc gouging and followed by a disc grinder to completely remove the remnants. The welders were noted working at 9 to 13 meters elevation. At the end of the shift, both welders have completed carbon air arc gouging and grinding three strong back remnants at this location.

At Tower Base Electro Slag Welding (ESW) 60-70 transition butt joint S-044 location C (face B), ABF welder Jorge Lopez was noted performing carbon arc gouging on the removal of the strong back remnants.

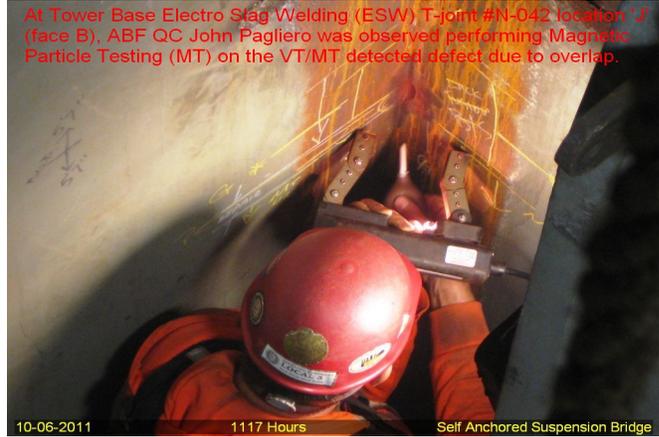
At Tower Base Electro Slag Welding (ESW) T-joint #N-042 location J (face B), ABF QC John Pagliero was observed performing Magnetic Particle Testing (MT) on the VT/MT detected defect due to overlap.
