DEPARTMENT OF TRANSPORTATION

Quality Assurance and Source Inspection

Contract #: 04-0120F4Cty: SF/ALA Rte: 80 PM: 13.2/13.9File #: 1.28**WELDING INSPECTION REPORT****Resident Engineer:** Casey, William**Address:** 333 Burma Road**City:** Oakland, CA 94607**Report No:** WIR-026478**Date Inspected:** 06-Oct-2011**Project Name:** SAS Superstructure**OSM Arrival Time:** 700**Prime Contractor:** American Bridge/Fluor Enterprises, a JV**OSM Departure Time:** 1730**Contractor:** American Bridge/Fluor Enterprises, a JV**Location:** Jobsite

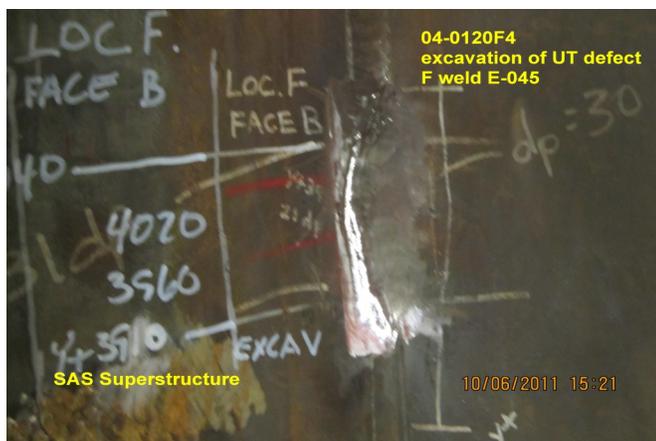
The QA inspector randomly observed ABF welding personnel Jeremy Dolman utilizing carbon air arc to excavate the majority of the repair followed by grinding using a die grinder on F joint E-045 face "B". The QA inspector noted the dimensions of the excavation as 220mm's in length, 55mm's wide and 40mm's in depth. The QA Inspector observed the QC Inspector identified as John Pagliero perform Magnetic Particle inspection on the excavations and found them to be free of indications. The QA inspector verified that the proper procedure was utilized as well as correct technique. Welding did not commence on this date and the QA inspector noted that the work appeared to be in general conformance with the contract documents.

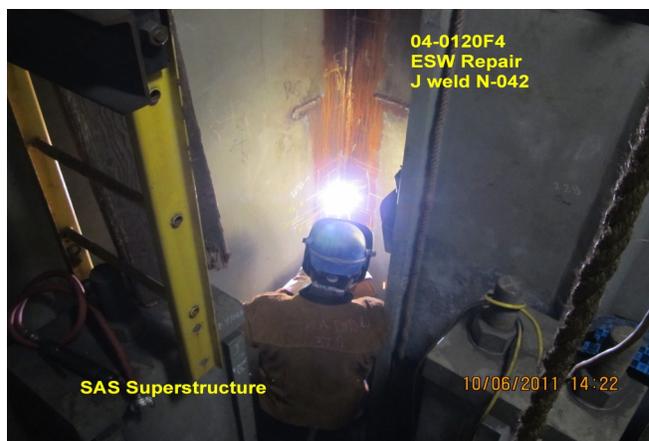
The QA inspector randomly observed ABF welding personnel Fred Kaddu utilizing carbon air arc to excavate the majority of the repair followed by grinding using a die grinder on J joint N-042 face "B". The QA inspector noted the dimensions of the excavation as 85mm's in length, 20mm's wide and 10mm's in depth. The QA Inspector observed the QC Inspector identified as Sal Moreno perform Magnetic Particle inspection on the excavations and found them to be free of indications. The QA inspector verified that the proper procedure was utilized as well as correct technique. The QA inspector observed ABF welder Fred Kaddu ID#2188 perform Shielded Metal Arc Welding (SMAW) in the 3G vertical position with the QC Inspector being present in order to monitor the welding and ensure the welding parameters were in compliance pertaining to ABF-WPS-D15-1001-Repair Rev. 2. The QA Inspector noted that the work is in progress and appeared to be in general conformance with the contract documents.
