**DEPARTMENT OF TRANSPORTATION**

Contract #: 04-0120F4Cty: SF/ALA Rte: 80 PM: 13.2/13.9File #: 1.28**WELDING INSPECTION REPORT****Resident Engineer:** Casey, William**Address:** 333 Burma Road**City:** Oakland, CA 94607**Report No:** WIR-026479**Date Inspected:** 07-Oct-2011**Project Name:** SAS Superstructure**OSM Arrival Time:** 700**Prime Contractor:** American Bridge/Fluor Enterprises, a JV**OSM Departure Time:** 1730**Contractor:** American Bridge/Fluor Enterprises, a JV**Location:** Job Site**CWI Name:** John Pagliero and Pat Swain**CWI Present:** Yes No**Inspected CWI report:** Yes No N/A**Rod Oven in Use:** Yes No N/A**Electrode to specification:** Yes No N/A**Weld Procedures Followed:** Yes No N/A**Qualified Welders:** Yes No N/A**Verified Joint Fit-up:** Yes No N/A**Approved Drawings:** Yes No N/A**Approved WPS:** Yes No N/A**Delayed / Cancelled:** Yes No N/A**Bridge No:** 34-0006**Component:** SAS Tower**Summary of Items Observed:**

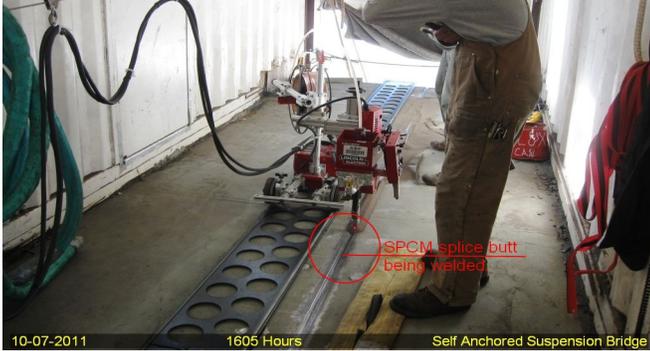
At OBG 12E/13E top deck plate 'A3 to A5' (outside), QA randomly observed ABF certified welder Todd Jackson ID #4639 continuing to perform 1G (flat position) Submerged Arc Welding (SAW) welding fill pass on the splice butt joint. The welder was utilizing F7A6-EM12K-H8, 3.2mm electrode with corresponding Esab OK Flux 10.62 flux and implementing Caltrans approved Welding Procedure Specification (WPS) ABF-WPS-D15-4042B-1. The joint being welded has a single V-groove butt joint with backing bar. The plates were preheated to more than 150 °F using Miller Proheat 35 Induction Heating System located on top of the plate prior welding and moving it the side during welding. ABF/QC Pat Swain was noted monitoring the welding parameters of the welder during welding. QA noted the welding parameters of 550 amperes, 32.0 volts with travel speed of 380 mm per minute and calculated heat input of 2.78 Kjoules per mm. The workmanship and appearance of the completed fill weld deemed satisfactory to the requirements of Seismic Performance Critical Members (SPCM). At the end of the shift, SAW fill pass welding was still continuing and should remain tomorrow.

At OBG 12E/13E top deck plate A8 to A5 outside, ABF welder Todd Jackson was observed performing 1G Submerged Arc Welding (SAW) welding fill pass on Seismic Performance Critical Members (SPCM) splice butt joint.

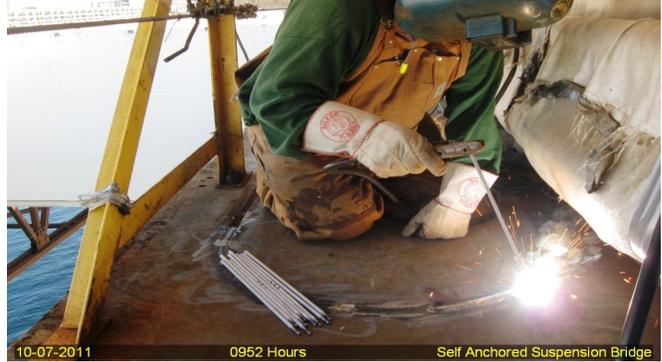
At OBG 8E-PP70.5-E5-NE access hole infill plate to top deck plate outside, QA randomly observed ABF/JV qualified welder Salvador Sandoval perform CJP groove fill pass welding. The welder was observed welding in the 1G (flat) position utilizing Shielded Metal Arc Welding (SMAW) with 5/32" diameter E7018H4R electrode implementing welding procedure ABF-WPS-D15-1010 Revision 1. The joint being welded has a double V-groove butt joint with open root welded from the bottom. ABF Quality Control (QC) Salvador Merino was noted monitoring the welding parameters of the welder. Measured welding parameter during welding was 190 amperes on a 5/32" diameter E7018H4R electrode. At the end of the shift, fill pass welding of the butt joint at location mentioned above was still continuing and should remain Monday.

At OBG 8E-PP70.5-E5 NorthEast deck access hole (outside), ABF welder Salvador Sarmol was observed performing 1G Shielded Metal Arc Welding (SMAW) welding fill pass on the radius of the butt joint.

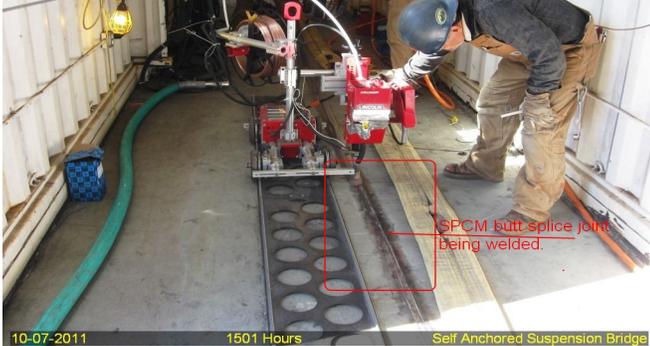
At OBG 12E/13E top deck plate 'A1 to A3' (outside), QA randomly observed ABF certified welder James Zhen ID #6001 continuing to perform 1G (flat position) Submerged Arc Welding (SAW) welding fill pass on the splice butt joint. The welder was utilizing F7A6-EM12K-H8, 3.2mm electrode with corresponding Esab OK Flux 10.62 flux and implementing Caltrans approved Welding Procedure Specification (WPS) ABF-WPS-D15-4042B-1. The joint being welded has a single V-groove butt joint with backing bar. The plates were preheated to more than 150 °F using Miller Proheat 35 Induction Heating System located on top of the plate prior welding and moving it the side during welding. ABF/QC Pat Swain was noted monitoring the welding parameters of the welder during welding. QA noted the welding parameters of 570 amperes, 32.4 volts with travel speed of 380 mm per minute and calculated heat input of 2.91Kjoules per mm. The workmanship and appearance of the completed fill weld deemed satisfactory to the requirements of Seismic Performance Critical Members (SPCM). At the end of the shift, SAW fill pass welding was still continuing and should remain tomorrow.

At OBG 12E/13E top deck plate splice butt joint (outside), ABF welder James Zhao was observed performing 1G Submerged Arc Welding (SAW) welding fill pass on the Seismic Performance Critical Member (SPCM).

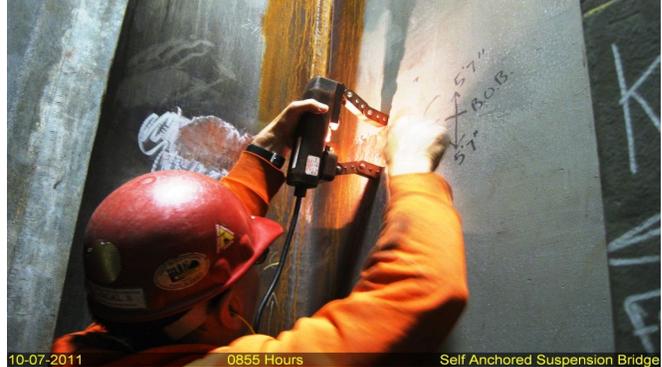
At Tower Base Electro Slag Welding (ESW) T-joint E-042 location "K" (face B), ABF QC John Pagliero was observed performing Magnetic Particle Testing (MT) on the complete removal of strong back.
