DEPARTMENT OF TRANSPORTATION

Contract #: 04-0120F4Cty: SF/ALA Rte: 80 PM: 13.2/13.9File #: 1.28**WELDING INSPECTION REPORT****Resident Engineer:** Casey, William**Address:** 333 Burma Road**City:** Oakland, CA 94607**Report No:** WIR-026492**Date Inspected:** 08-Oct-2011**Project Name:** SAS Superstructure**OSM Arrival Time:** 700**Prime Contractor:** American Bridge/Fluor Enterprises, a JV**OSM Departure Time:** 1530**Contractor:** American Bridge/Fluor Enterprises, a JV**Location:** Jobsite

Bridge No: 34-0006**Summary of Items Observed:**

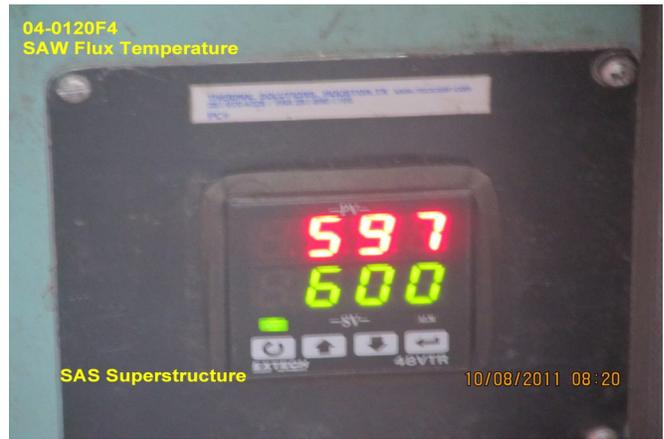
2. 12W 13W "A" Deck Welding (Exterior)

The QA inspector randomly observed ABF welding operators Rory Hogan ID#3186 performing Submerged Arc Welding (SAW) on "A" Deck at 12W 13W of the OBG. The QA inspector observed the QC inspector identified as William Sherwood monitoring the welding to ensure the welding parameters were in compliance pertaining to ABF-WPS-D15-4042 B-1. The parameters were recorded as (A=560/V=32.5/TS=410/HI=2.66). The QA inspector verified the temperature of the flux prior to welding operations and throughout the shift for compliance. The QA inspector made subsequent observations throughout the shift to monitor quality and noted that the work is in progress and appears to be in general conformance to the contract requirements. The QA inspector reviewed the observations and inspection with QA SPCM Lead Inspector, Daniel Reyes, written in this report. No issues were noted by the QA inspector and the QA SPCM Lead Inspector concurs with the QA report.
