DEPARTMENT OF TRANSPORTATION

Contract #: 04-0120F4Cty: SF/ALA Rte: 80 PM: 13.2/13.9File #: 99.28**WELDING INSPECTION REPORT****Resident Engineer:** Casey, William**Address:** 333 Burma Road**City:** Oakland, CA 94607**Report No:** WIR-026500**Date Inspected:** 10-Oct-2011**Project Name:** SAS Superstructure**OSM Arrival Time:** 1100**Prime Contractor:** American Bridge/Fluor Enterprises, a JV**OSM Departure Time:** 1900**Contractor:** Watson Bowman ACME**Location:** Buffalo, NY**CWI Name:** Reno Davis, John Crabtree**CWI Present:** Yes No**Inspected CWI report:** Yes No N/A**Rod Oven in Use:** Yes No N/A**Electrode to specification:** Yes No N/A**Weld Procedures Followed:** Yes No N/A**Qualified Welders:** Yes No N/A**Verified Joint Fit-up:** Yes No N/A**Approved Drawings:** Yes No N/A**Approved WPS:** Yes No N/A**Delayed / Cancelled:** Yes No N/A**Bridge No:** 34-0006**Component:** OBG**Summary of Items Observed:**

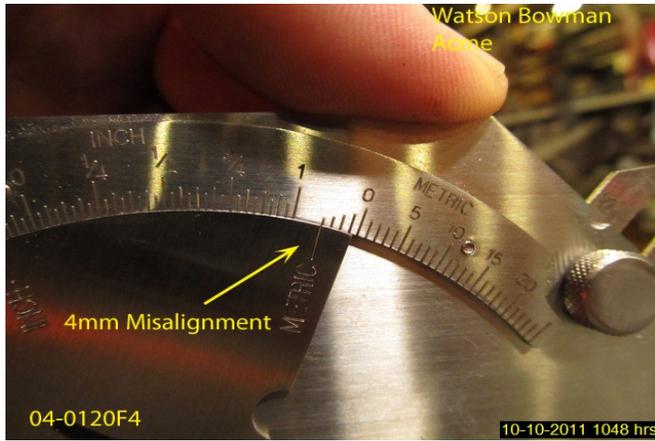
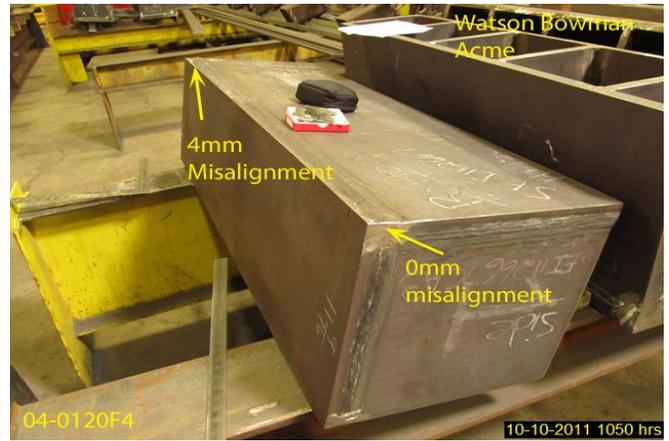
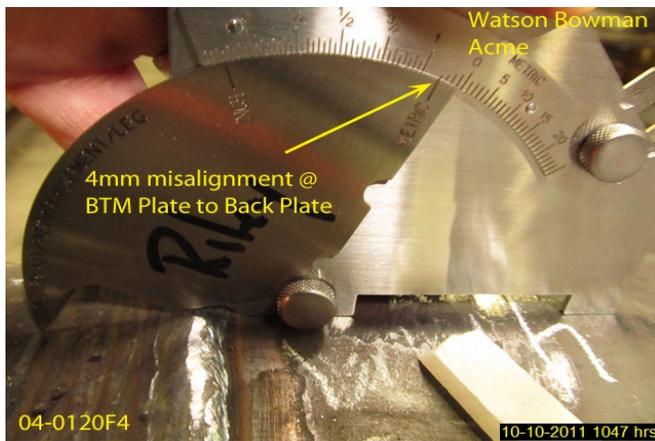
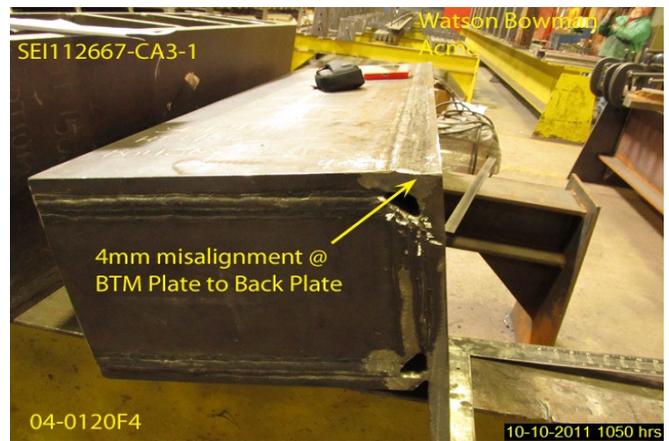
This QAI was informed by the ABF QC that component SEI112667 CA3-1 bottom plate to top plate has what appears to be misalignment of 4mm. The back plate starts at 0mm and continuous to the 4mm mark giving the component a 1mm misalignment. This has been informed to WBA for rectification due to the 4mm does not meet the tolerance as outlined in section 3.3.3 of AWS D1.5. WBA stated they would be submitting a RFI for this issue. See Photos Below.

The night shift welder John DiVirgillio would not be welding on this project tonight. This QAI was informed that welder Nikolas Mattoon would be replacing Mr. DiVirgillio due to he was needed on the robotic system. Mr. Mattoon or WBA personnel did not work on the Channel components tonight. ABF QC inspector John Crabtree was onsite to monitor WBA but due to no work he performed Visual and dimensional checks on the components that have been completed up to this date. Mr. Crabtree did find the misalignment on component CA3-1 bottom plate and informed this QAI.
