**DEPARTMENT OF TRANSPORTATION**

Contract #: 04-0120F4Cty: SF/ALA Rte: 80 PM: 13.2/13.9File #: 1.28**WELDING INSPECTION REPORT****Resident Engineer:** Casey, William**Address:** 333 Burma Road**City:** Oakland, CA 94607**Report No:** WIR-026503**Date Inspected:** 11-Oct-2011**Project Name:** SAS Superstructure**OSM Arrival Time:** 700**Prime Contractor:** American Bridge/Fluor Enterprises, a JV**OSM Departure Time:** 1730**Contractor:** American Bridge/Fluor Enterprises, a JV**Location:** Job Site

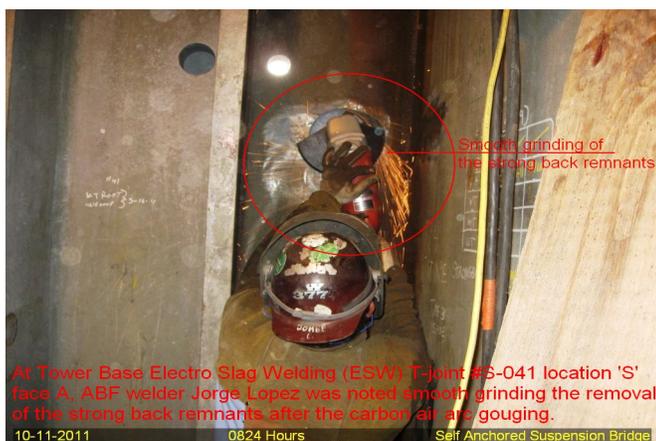
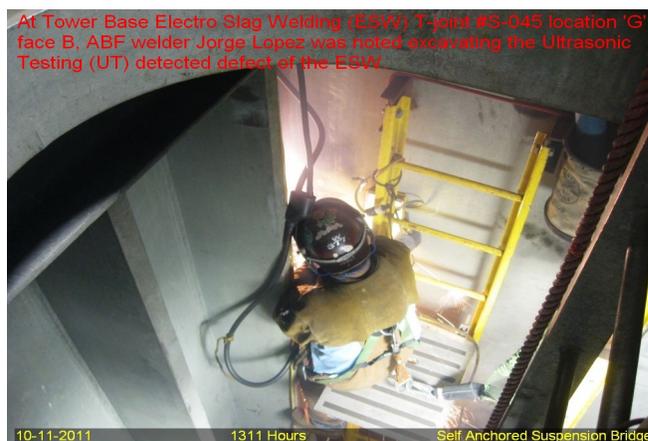
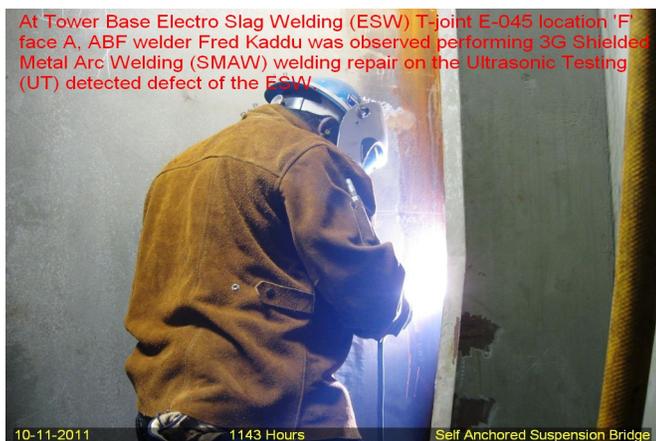
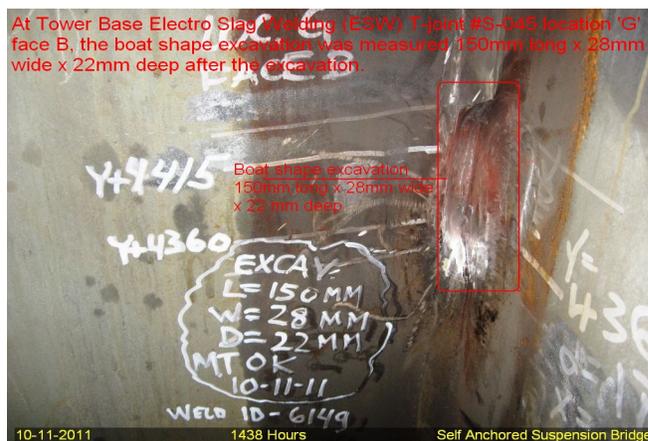
At Tower Base Elevation Electro Slag Welding (ESW) T-joint E-045 location 'F' face A, QA randomly ABF welder Fred Kaddu perform 3G SMAW first time welding repair (R1) on the Ultrasonic Testing (UT) detected defect on the vertical weld of the ESW. The welder was observed welding in the 3G (vertical) position utilizing Shielded Metal Arc Welding (SMAW) with 1/8" diameter E7018H4R electrode implementing welding procedure ABF-WPS-D15-1000-Repair Rev. 2. The boat shape repair excavation located at Y=3380mm was excavated to dimensions of 290mm long x 25mm wide x 17mm deep. The excavation was tested using Magnetic Particle Testing (MT) by ABF QC John Pagliero and verified by this QA with positive result. The repair excavation and the adjacent base metal were preheated to more than 300°F using the propylene gas torch. Prior welding, Caltrans Engineer Saman has verbally approved the repair of the weld joint. During the shift, ABF QC Bernie Docena was noted monitoring the welder. Measured welding parameter during welding was 125 amperes on a 1/8" diameter E7018H4R electrode. At the end of the shift, repair welding at location mentioned above was completed.

At Tower Base Electro Slag Welding (ESW) T-joints #S-041 location 'S' (face A) and E-041 location 'R' face A, ABF QC Bernie Docena was observed performing Magnetic Particle Testing (MT) on the removal of the remnants of the welded temporary strong back attachments. The QC Inspector was noted performing MT on the two ESW weld joints elevation 9 to 13 meters. There was no MT indication noted during the test.

At Tower Base Elevation Electro Slag Welding (ESW) T-joint S-045 location 'G' face B, QA randomly observed ABF welder Jorge Lopez excavate the Ultrasonic Testing (UT) detected defect at ESW welded T-joint using carbon air arc gouging. Prior the excavation, the welder has preheated the defect location to more than 250°F using the propylene gas torch. ABF QC Bernie Docena has performed the Magnetic Particle Testing (MT) as the welder chase the extent of the indication. The repair excavation was located at Y=3380mm and has a boat shape dimensions of 150mm long x 28mm wide x 22mm deep. The repair excavation was tested by ABF QC Bernie Docena using Magnetic Particle Testing (MT) with positive result. This QA performed VT/MT verification on the defect removal and noted same result. After the excavation and testing on the defect removal of the defect, QC has informed this QA that QC will initiate the Request for Welding Repair (RWR) and forward it to ABF for Caltrans approval.
