Contract #: 04-0120F4Cty: SF/ALA Rte: 80 PM: 13.2/13.9File #: 1.28**WELDING INSPECTION REPORT**

Report No: WIR-026524
Date Inspected: 14-Oct-2011

Project Name: SAS Superstructure
Prime Contractor: American Bridge/Fluor Enterprises, a JV
Contractor: American Bridge/Fluor Enterprises, a JV

CWI Name:	As noted below.	CWI Present:	Yes	No
Inspected CWI report:	Yes No N/A	Rod Oven in Use:	Yes No N/A	
Electrode to specification:	Yes No N/A	Weld Procedures Followed:	Yes No N/A	
Qualified Welders:	Yes No N/A	Verified Joint Fit-up:	Yes No N/A	
Approved Drawings:	Yes No N/A	Approved WPS:	Yes No N/A	
		Delayed / Cancelled:	Yes No N/A	
Bridge No:	34-0006	Component:	OBG Component

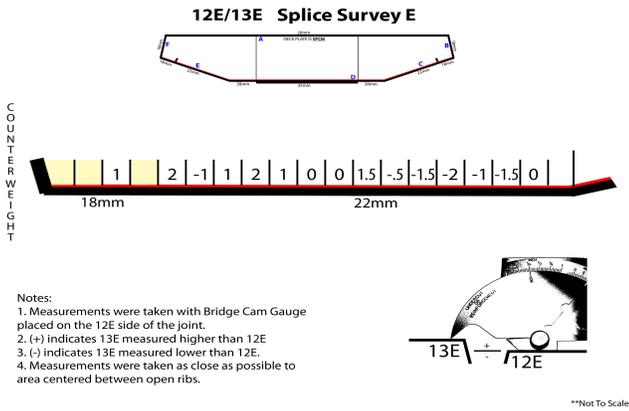
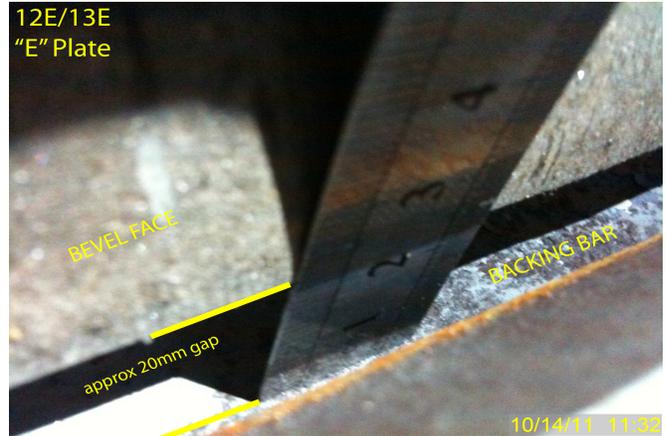
Approximately 11:00 QA observed the joint fit-up for connection 12E/13E “E” side plate. QA noted that the backing bar from approximately (Y=1524mm ~ 3657mm) was not within 2mm of base material. The gap between the backing bar and the base material measured from (15mm ~ 25mm) at various locations throughout aforementioned Y locations.

Please see attached photograph for visual representation.
