DEPARTMENT OF TRANSPORTATION

Contract #: 04-0120F4Cty: SF/ALA Rte: 80 PM: 13.2/13.9File #: 1.28**WELDING INSPECTION REPORT****Resident Engineer:** Casey, William**Address:** 333 Burma Road**City:** Oakland, CA 94607**Report No:** WIR-026532**Date Inspected:** 13-Oct-2011**Project Name:** SAS Superstructure**OSM Arrival Time:** 700**Prime Contractor:** American Bridge/Fluor Enterprises, a JV**OSM Departure Time:** 1530**Contractor:** American Bridge/Fluor Enterprises, a JV**Location:** Job Site**CWI Name:** Fred Von Hoff**CWI Present:** Yes No**Inspected CWI report:** Yes No N/A**Rod Oven in Use:** Yes No N/A**Electrode to specification:** Yes No N/A**Weld Procedures Followed:** Yes No N/A**Qualified Welders:** Yes No N/A**Verified Joint Fit-up:** Yes No N/A**Approved Drawings:** Yes No N/A**Approved WPS:** Yes No N/A**Delayed / Cancelled:** Yes No N/A**Bridge No:** 34-0006**Component:** OBG Sections**Summary of Items Observed:**

WELDING INSPECTION REPORT

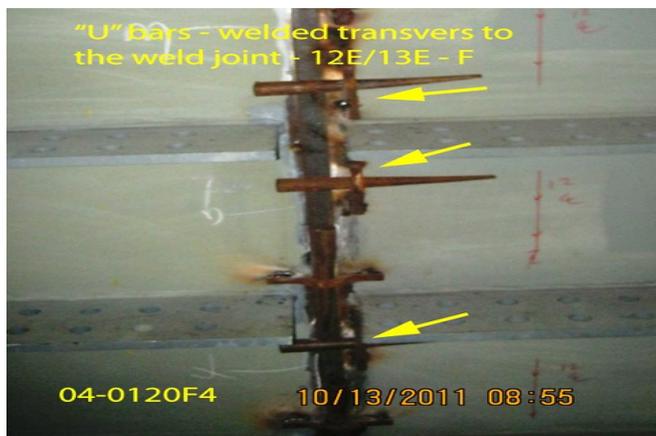
12E/13E weld joint F: This QA Inspector randomly observed ABF welding personnel Jorge Lopez (#6149) setting up to gain access and start cleaning the weld joint. This QA Inspector observed QC Inspector Fred Von Hoff perform a visual inspection of the fit up at this location. This QA Inspector performed a verification of the fit up and observed the following; Y-0 to 110 the planar offset was from 6 mm (at Y-0) to 2 mm (at Y-110), Y-2095 to

Y-2315 the planar offset was 2 mm (at Y-2095) to 5 mm (at Y-2315), from Y-1420 to Y-1495 the root opening exceeded the maximum allowed and at the largest area was 17 mm, the backing bar at the bottom 580 mm (Y-1735 to Y-2315) appeared to have a gap ranging from 2 mm (at Y-1735) to 9 mm (at Y-2315). QC Inspector Fred Von Hoff was aware of the issues noted above. This QA Inspector observed that "U bars" had been used as fit up aids on the inside of the OBG section and had been welded on in a transverse direction, see photo below. This QA Inspector provided a complete turnover to QA Inspector Jojo Lizardo regarding these issues at the end of this QA Inspectors shift for further verifications.
