DEPARTMENT OF TRANSPORTATION

Contract #: 04-0120F4Cty: SF/ALA Rte: 80 PM: 13.2/13.9File #: 1.28**WELDING INSPECTION REPORT****Resident Engineer:** Casey, William**Address:** 333 Burma Road**City:** Oakland, CA 94607**Report No:** WIR-026554**Date Inspected:** 21-Oct-2011**Project Name:** SAS Superstructure**OSM Arrival Time:** 700**Prime Contractor:** American Bridge/Fluor Enterprises, a JV**OSM Departure Time:** 1530**Contractor:** American Bridge/Fluor Enterprises, a JV**Location:** Job Site**CWI Name:** Jesus Cayabyab**CWI Present:** Yes No**Inspected CWI report:** Yes No N/A**Rod Oven in Use:** Yes No N/A**Electrode to specification:** Yes No N/A**Weld Procedures Followed:** Yes No N/A**Qualified Welders:** Yes No N/A**Verified Joint Fit-up:** Yes No N/A**Approved Drawings:** Yes No N/A**Approved WPS:** Yes No N/A**Delayed / Cancelled:** Yes No N/A**Bridge No:** 34-0006**Component:** OBG Sections**Summary of Items Observed:**

Orthotropic Bridge Girder (OBG) Sections:

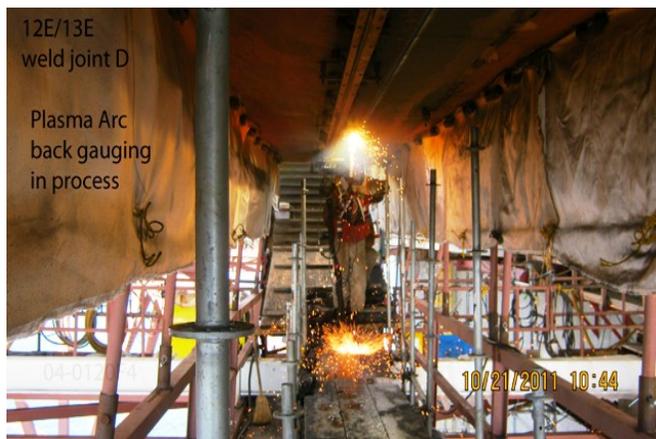
12E/13E weld joint D-1, D-2 and D-3: This QA Inspector randomly observed ABF welding personnel Wai Kitlai (#2953) using the plasma arc torch to remove the backing bar and back gouge the weld, see photo below. This QA Inspector observed later in the shift that grinding had been performed on the majority of the back gouged weld. This QA Inspector performed a random visual inspection at several short areas to determine the depth of back gouge and to see if the weld contained any visual defects. This QA Inspector observed a 60 mm long slag line at a back gouged depth of approximately 11-12 mm deep, see photo below, there were two other small indications adjacent to the slag line. At a short distance from this location this QA Inspector observed what appeared to be a large slag pocket about 4-5 mm long but had a depth of 3-4 mm. Note this was an in process observation; grinding had been started and the areas observed had been back gouged to approximately 10-12 mm deep and ground to bright metal, but grinding was still in process to remove defects such as the ones noted above.
