Contract #: 04-0120F4Cty: SF/ALA Rte: 80 PM: 13.2/13.9File #: 1.28**WELDING INSPECTION REPORT**

Report No: WIR-026558
Date Inspected: 22-Oct-2011

Project Name: SAS Superstructure
Prime Contractor: American Bridge/Fluor Enterprises, a JV
Contractor: American Bridge/Fluor Enterprises, a JV

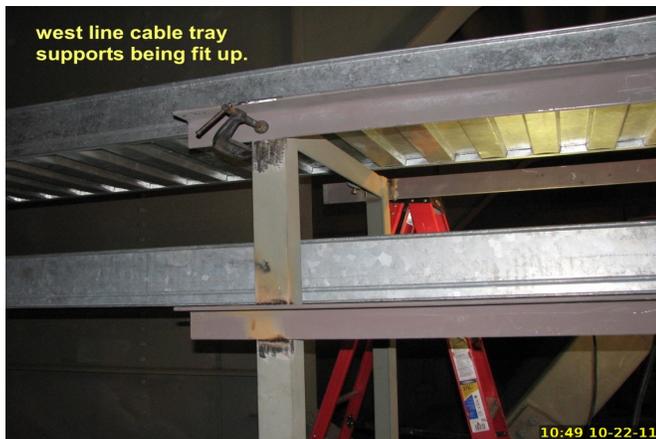
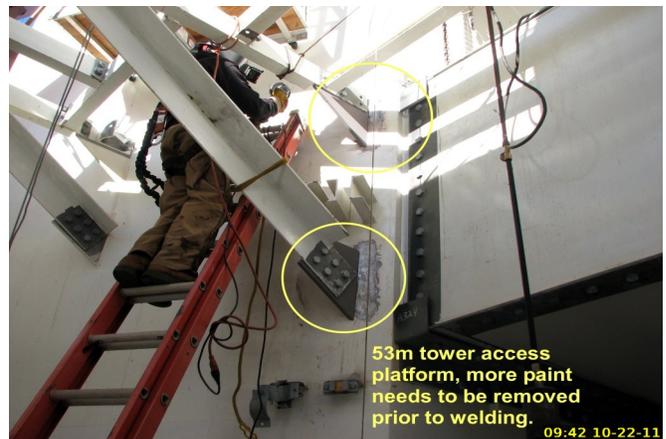
1) 2) The QAI observed ABF personnel installing and fillet welding steel angle members into cable tray supports at Orthotropic Box Girder (OBG) segments 2W (Crossbeam 1) and 5W (Crossbeam 4). The QAI noted that the contract requirements for this welding are specified to use American Welding Society (AWS) D1.1, code year 2002. The QAI noted that 2 crews are performing this work. At crossbeam 1 in the West bound OBG, ABF welder Mike Jiminez, ID 4671, and at crossbeam 4 in the West bound OBG, ABF welder Eric Sparks, ID 3040. The QAI noted that these welders are performing similar tasks at each area including, fitting and welding the cable tray supports at the OBG / Crossbeam transition areas. The QAI observed that the Quality Control Inspector (QCI) Steve Jensen is monitoring this welding. The QAI noted that the zinc primer is being / has been ground off of the areas to be welded, the parts are then fit and tack welded with 6mm fillet welds being placed after fit-up has been accepted by the QCI. The QAI made random observations of the work in progress and noted that it appeared to be conforming to the contract requirements. The QAI was informed that after completion of work at each location, a painting crew will re-apply the zinc primer to the areas where welding was performed. The QAI noted that this will happen at a later time. See the attached photos.
