DEPARTMENT OF TRANSPORTATION

Contract #: 04-0120F4Cty: SF/ALA Rte: 80 PM: 13.2/13.9File #: 1x.28**WELDING INSPECTION REPORT****Resident Engineer:** Casey, William**Address:** 333 Burma Road**City:** Oakland, CA 94607**Report No:** WIR-026578**Date Inspected:** 27-Oct-2011**Project Name:** SAS Superstructure**OSM Arrival Time:** 630**Prime Contractor:** American Bridge/Fluor Enterprises, a JV**OSM Departure Time:** 1730**Contractor:** American Bridge/Fluor Enterprises, a JV**Location:** On Site**CWI Name:** Pat Swain**CWI Present:** Yes No**Inspected CWI report:** Yes No N/A**Rod Oven in Use:** Yes No N/A**Electrode to specification:** Yes No N/A**Weld Procedures Followed:** Yes No N/A**Qualified Welders:** Yes No N/A**Verified Joint Fit-up:** Yes No N/A**Approved Drawings:** Yes No N/A**Approved WPS:** Yes No N/A**Delayed / Cancelled:** Yes No N/A**Bridge No:** 34-0006**Component:** OBG Sections**Summary of Items Observed:**

OBG Deck Plate Field Splice 11E / 12E:

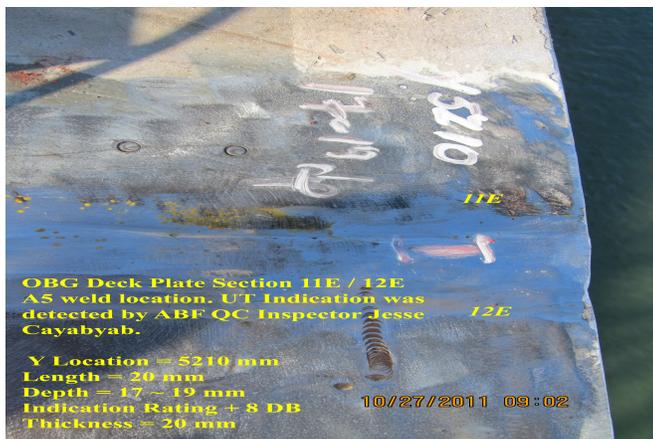
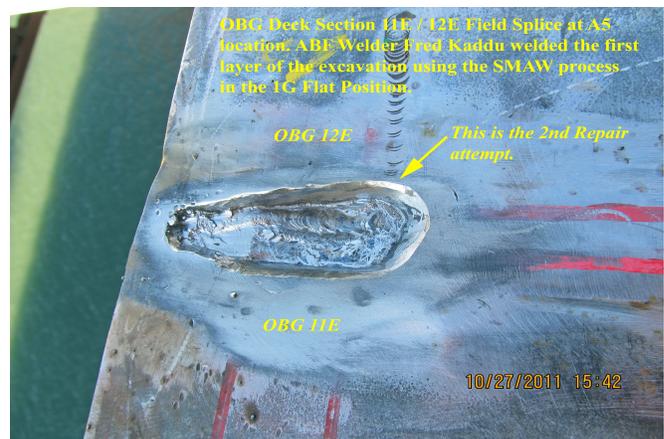
This QA Inspector randomly observed QC Inspector Mr. Pat Swain perform a preliminary ultrasonic inspection of the repaired area on OBG deck plate section 11E / 12E at weld location A5. This QA Inspector observed that Mr. Swain detected a rejectable ultrasonic indication at "Y" location 5200 mm. The deck plate section is 20 mm thick and the depth of the ultrasonic indication was 20 mm. The length of the indication was 20 mm and the indication rating was a (+10) db.

This QA Inspector randomly observed ABF welder Mr. Fred Kaddu performing the back-gouge operation for the second time of an ultrasonic rejectable indication on OBG deck plate section 11E / 12E located at "Y" location 5200 mm. The excavated area for repair was: (25 mm wide; 75 mm length; and 20 mm in depth).

This QA Inspector randomly observed ABF welder Mr. Fred Kaddu (Welder ID 2188) performing the repair welding operation for the second time on an excavation as per the Shielded Metal Arc Welding (SMAW) process in the (1G) flat position on OBG deck plate section 11E / 12E at weld location A5. The excavated area was as noted above for the second time and this QA Inspector observed QC Inspector Mr. Jesse Cayabyab verify that the preheat temperature was at the minimum of 125 Degrees F and that the welding parameters (Amps, Volts, and Travel Speed) were in accordance with WPS D1.5 - 1000 Repair Revision 2. The welding parameters observed at this location appeared to be in general compliance with approved WPS and the contract specifications.

The welding of the second repair at the location mentioned above was completed on this date and the preliminary UT inspection will be performed on October 28th, 2011.
