Contract #: 04-0120F4Cty: SF/ALA Rte: 80 PM: 13.2/13.9File #: 1.28**WELDING INSPECTION REPORT**

Report No: WIR-026584
Date Inspected: 26-Oct-2011

Project Name: SAS Superstructure
Prime Contractor: American Bridge/Fluor Enterprises, a JV
Contractor: American Bridge/Fluor Enterprises, a JV

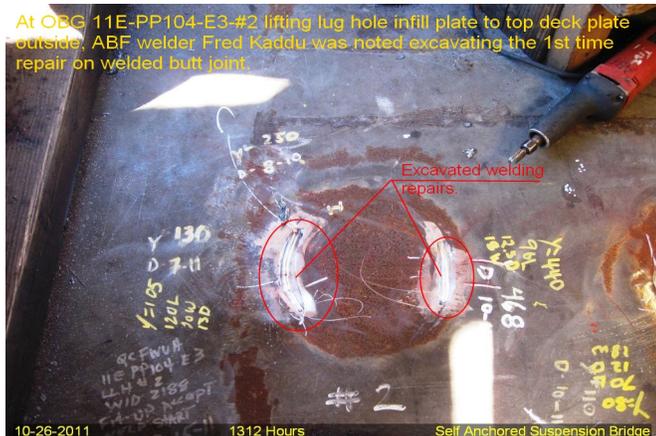
10-26-2011 1312 Hours Self Anchored Suspension Bridge

At OBG 11E-PP104-E3-#2 lifting lug hole infill plate to top deck plate outside, ABF welder Fred Kaddu was noted excavating the 1st time repair on welded butt joint.

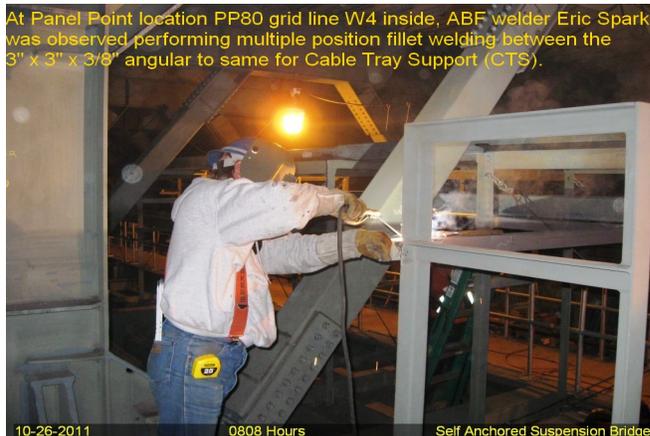
10-26-2011 0808 Hours Self Anchored Suspension Bridge

At Panel Point location PP80 grid line W4 inside, ABF welder Eric Sparks was observed performing multiple position fillet welding between the 3" x 3" x 3/8" angular to same for Cable Tray Support (CTS).
