Contract #: 04-0120F4Cty: SF/ALA Rte: 80 PM: 13.2/13.9File #: 1x.28**WELDING INSPECTION REPORT**

Report No: WIR-026592
Date Inspected: 28-Oct-2011

Project Name: SAS Superstructure
Prime Contractor: American Bridge/Fluor Enterprises, a JV
Contractor: American Bridge/Fluor Enterprises, a JV

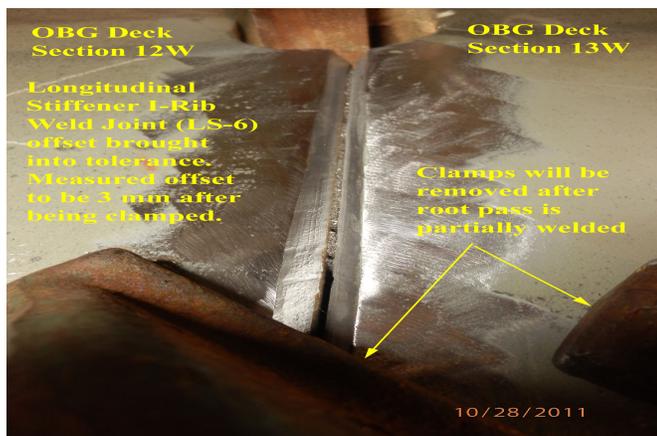
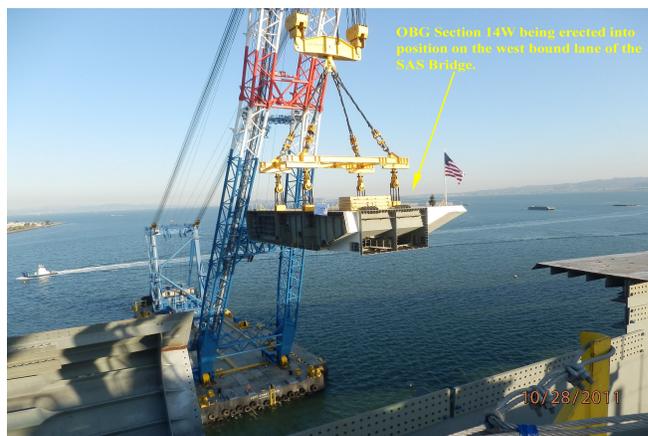
operation of I-Rib Longitudinal Stiffener (LS-6) on the inside of OBG Deck Plate Section 12W ~ 13W. At this location, the I-Rib LS is A709 GR. 485 material. This QA Inspector observed QC Inspector Mr. Tony Sherwood measure the offset between the I-Rib LS and the results of the offset was 7 mm. The thickness of the LS stiffener at this location was 30 mm. The allowable offset tolerance at this location is 3 mm. Afterwards, this QA Inspector observed ABF welder Mr. Kaddu use bridge clamps to bring the offset between the two I-Rib LS's to within the 3 mm tolerance. ABF Welder Mr. Kaddu placed the heat induction blanket across the weld joint to start the preheat operation and once the preheat temperature of 200 Degrees F was reached, Mr. Kaddu was ready to perform the root pass weld operation per the SMAW process in the (3G) Vertical position using 1/8" diameter 9018M electrode. This QA Inspector verified that the 9018M electrodes being used to perform the root pass weld operation were stored and removed from a heated quiver. This QA Inspector also observed QC Inspector Mr. Sherwood verify that the welding parameters and preheat temperature were in general compliance with WPS-D1.5 1012-3 Revision 0 prior to the start of the root pass welding operation on LS-6. The root pass weld operation was partially completed along the 230 mm weld length of LS-6 and afterwards this QA Inspector observed welder Mr. Kaddu remove the bridge clamps to complete the root pass weld operation for the full length of the weld joint. The root pass weld operation was in-process at the end of the QA Inspectors' shift and QC Inspector Mr. Sherwood will stay at the location to monitor the completion of the root pass weld operation.
