**DEPARTMENT OF TRANSPORTATION**

Contract #: 04-0120F4Cty: SF/ALA Rte: 80 PM: 13.2/13.9File #: 1.28**WELDING INSPECTION REPORT****Resident Engineer:** Casey, William**Address:** 333 Burma Road**City:** Oakland, CA 94607**Report No:** WIR-026593**Date Inspected:** 27-Oct-2011**Project Name:** SAS Superstructure**OSM Arrival Time:** 700**Prime Contractor:** American Bridge/Fluor Enterprises, a JV**OSM Departure Time:** 1730**Contractor:** American Bridge/Fluor Enterprises, a JV**Location:** Job Site**CWI Name:** Fred Von Hoff**CWI Present:** Yes No**Inspected CWI report:** Yes No N/A**Rod Oven in Use:** Yes No N/A**Electrode to specification:** Yes No N/A**Weld Procedures Followed:** Yes No N/A**Qualified Welders:** Yes No N/A**Verified Joint Fit-up:** Yes No N/A**Approved Drawings:** Yes No N/A**Approved WPS:** Yes No N/A**Delayed / Cancelled:** Yes No N/A**Bridge No:** 34-0006**Component:** OBG Sections**Summary of Items Observed:**

**Orthotropic Bridge Girder (OBG) Sections:**

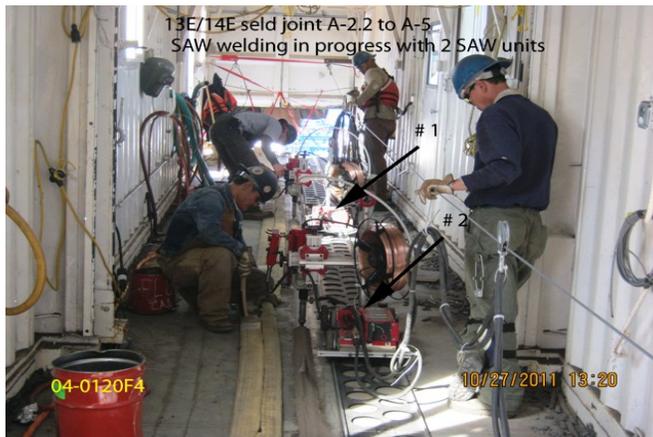
observed that shortly after welding had started ABF Welding Supervisor Danny Ieraci (#3232) took the place of ABF welding personnel Todd Jackson (#4639). QC Inspector Fred Von Hoff verified the amperage, voltage and travel speed did not change after the change in welding personnel. This QA Inspector observed ABF Welding Supervisor Danny Ieraci (#3232) and ABF welding personnel Todd Jackson switched places later in the shift and that QC Inspector Fred Von Hoff verified the parameters did not change. This QA Inspector observed the SAW continued and the welding at this location was completed this shift.

11E-PP104-E3 Lifting Lug Hole (LLH) # 2: This QA Inspector observed ABF welding personnel Fred Kaddu (# 2188) had excavated a defect for repair welding at this location. This QA Inspector randomly observed QC Inspector Pat Swain perform a visual and Magnetic Particle Testing (MT) on the excavation area at Y-230 which had a length of 75 mm, width of 20 mm and a depth of 10 mm. This QA Inspector observed the area was preheated prior to welding and QC Inspector Pat Swain verify the following parameters; 130 amperes using a 3.2 mm diameter E7018H4R electrode. The welding observed by this QA Inspector appeared to comply with the Welding Procedure Specification (WPS), ABF-WPS-D15-1001-Repair, being used by the QC Inspector. This QA Inspector observed the repair welding at this location was completed this shift.
