**DEPARTMENT OF TRANSPORTATION**

Contract #: 04-0120F4Cty: SF/ALA Rte: 80 PM: 13.2/13.9File #: 1.28**WELDING INSPECTION REPORT****Resident Engineer:** Casey, William**Address:** 333 Burma Road**City:** Oakland, CA 94607**Report No:** WIR-026608**Date Inspected:** 31-Oct-2011**Project Name:** SAS Superstructure**OSM Arrival Time:** 700**Prime Contractor:** American Bridge/Fluor Enterprises, a JV**OSM Departure Time:** 1730**Contractor:** American Bridge/Fluor Enterprises, a JV**Location:** Job Site**CWI Name:** Salvador Merino**CWI Present:** Yes No**Inspected CWI report:** Yes No N/A**Rod Oven in Use:** Yes No N/A**Electrode to specification:** Yes No N/A**Weld Procedures Followed:** Yes No N/A**Qualified Welders:** Yes No N/A**Verified Joint Fit-up:** Yes No N/A**Approved Drawings:** Yes No N/A**Approved WPS:** Yes No N/A**Delayed / Cancelled:** Yes No N/A**Bridge No:** 34-0006**Component:** SAS OBG**Summary of Items Observed:**

# WELDING INSPECTION REPORT

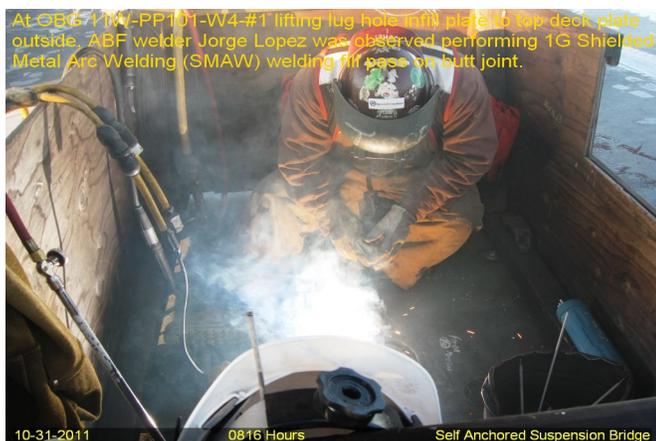
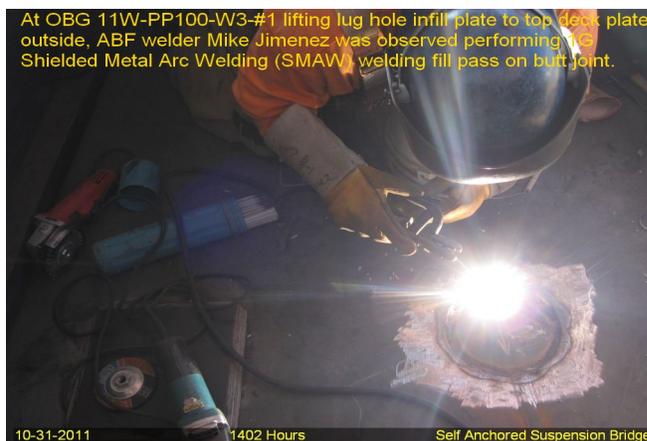
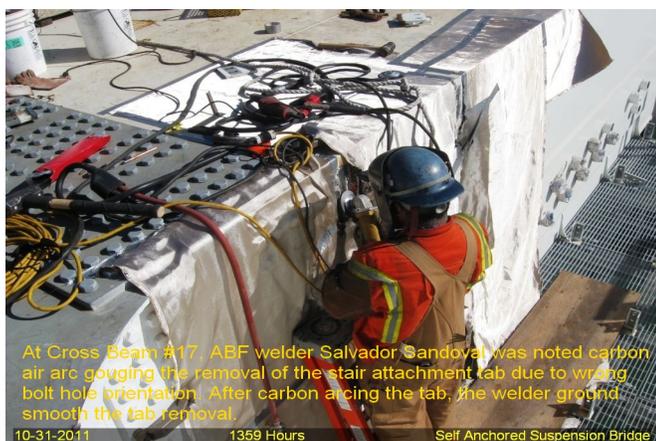
At OBG 11W-PP101-W4-# 1 lifting lug hole infill plate to top deck plate outside, ABF welder Jorge Lopez was observed continuing to perform 1G SMAW welding fill pass to cover pass on the infill plate to top deck plate butt joint. The welder was noted using 5/32" diameter E7018H4R electrode implementing Welding Procedure Specification (WPS) ABF-WPS-D15-1070. Prior welding, ABF QC Salvador Merino was observed inspecting the fit up of the butt joints. QA verified the fit up alignment of the lifting lug hole which deemed acceptable to the contract requirements. During welding, ABF QC Salvador Merino was noted monitoring the welder's welding parameters with measured working current of 190 amperes. During the shift, cover pass welding on the top side location of the butt joint was completed.

At OBG 11W-PP100-W3-# 1 lifting lug hole infill plate to top deck plate outside, ABF welder Mike Jimenez was observed performing 1G SMAW welding root pass to fill pass on the infill plate to top deck plate butt joint. The

At Cross Beam #17 outside, ABF welder Salvador Sandoval was observed removing the stair attachment tabs to the side of the Cross Beam using carbon air gouging followed by disc grinding. The tabs are being removed due to wrong bolt holes orientation and per Request for Information (RFI) ABF-RFI-002417R00 dated 19 April 2011. The welder has completed carbon arcing and grinding smooth the North side stair attachment tabs while the South side is still in progress.
