DEPARTMENT OF TRANSPORTATION

Contract #: 04-0120F4Cty: SF/ALA Rte: 80 PM: 13.2/13.9File #: 1.28**WELDING INSPECTION REPORT****Resident Engineer:** Casey, William**Address:** 333 Burma Road**City:** Oakland, CA 94607**Report No:** WIR-026612**Date Inspected:** 01-Nov-2011**Project Name:** SAS Superstructure**OSM Arrival Time:** 630**Prime Contractor:** American Bridge/Fluor Enterprises, a JV**OSM Departure Time:** 1730**Contractor:** American Bridge/Fluor Enterprises, a JV**Location:** On Site**CWI Name:** Pat Swain**CWI Present:** Yes No**Inspected CWI report:** Yes No N/A**Rod Oven in Use:** Yes No N/A**Electrode to specification:** Yes No N/A**Weld Procedures Followed:** Yes No N/A**Qualified Welders:** Yes No N/A**Verified Joint Fit-up:** Yes No N/A**Approved Drawings:** Yes No N/A**Approved WPS:** Yes No N/A**Delayed / Cancelled:** Yes No N/A**Bridge No:** 34-0006**Component:** OBG Segments**Summary of Items Observed:**

WELDING INSPECTION REPORT

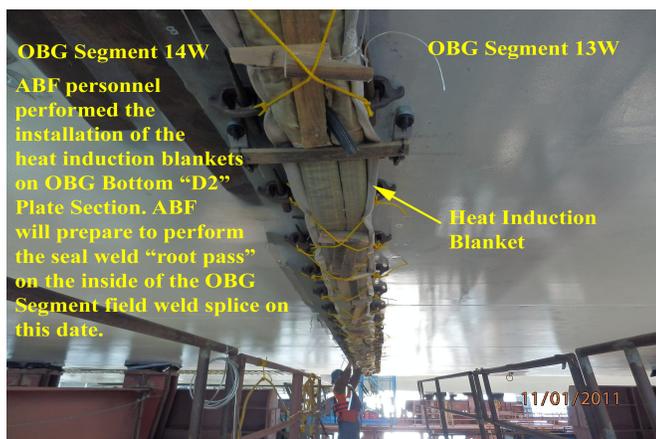
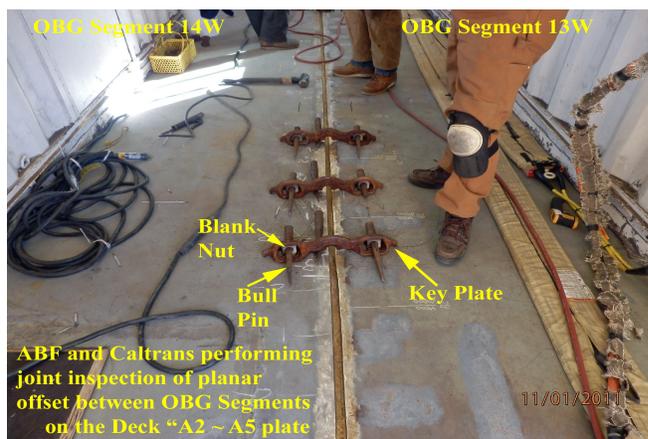
This QA Inspector along with QC Inspector Mr. Pat Swain performed the preliminary planar offset measurements on the inside of OBG Bottom Plate "D2" plate section at OBG Segment 13W ~ 14W field splice. This inspection is part of a joint inspection agreed upon between Caltrans and ABF. The preliminary planar offset measurements were recorded on the bottom plate for review by Caltrans Lead Inspector Mr. Danny Reyes prior to performing the final planar offset measurements. Except on the South side of the full height diaphragm at location W3 (offset measured 3.5 mm), the planar offset measurement readings appeared to be in general compliance with the contract specifications.

This QA Inspector randomly observed ABF welders' Mr. James Zhen (Welder ID 6001), Mr. Xiao Jian Wan (Welder ID 9667), and Mr. Wai Kitlai (Welder ID 2953) positioning the heat induction blankets for preheating on the outside of OBG Bottom Plate "D2" plate section in preparation to performing the Flux Cored Arc Welding (FCAW) process seal weld root pass in the (2G) horizontal position on the inside of "D2" plate. Afterwards, this QA Inspector observed QC Inspector Mr. Pat Swain verify prior to the start of welding that the welding parameters for the aforementioned welders were in accordance with WPS-3200-2. This QA Inspector also verified that the preheat temperature of the groove weld and surrounding base metal was at the minimum preheat temperature of

200 degrees F. The seal weld root pass was completed on the inside of OBG Bottom Plate "D2" section at the field splice of OBG Segment 13W ~ 14W.

This QA Inspector along with QC Inspector Mr. Junior Daquinag performed the preliminary planar offset measurements on the outside of OBG Deck Plate "A2 ~ A5" section at OBG Segment 13W ~ 14W field splice. This inspection is part of a joint inspection agreed upon between Caltrans and ABF. The preliminary planar offset measurements were recorded on the deck plate for review by Caltrans Lead Inspector Mr. Danny Reyes prior to performing the final planar offset measurements. There were several areas inspected along the length of the Deck Plate "A2 ~ A5" that were outside the tolerance allowed for the planar offset. This QA Inspector observed ABF welder Mr. Rick Clayborn proceed to perform the fillet weld operation per the Shielded Metal Arc Weld (SMAW) process in the (2F) horizontal position on "Blank" nuts located across the field weld splice to fit the "Key" plate over the nuts and thereafter drive the bull pins through blank nuts and utilize the "Key" plate" to pull down one side of the deck plate across the field weld splice to reduce the planar offset values and try to bring the values into compliance. This QA Inspector also observed that "U" bars were also used as needed on areas where the "Key" plate was located and the planar offset values were still outside of the specified offset tolerance. The thickness of the Deck Plate at this field weld splice location was 20 mm. This QA Inspector observed QC Inspector Mr. Junior Daquinag verify prior to the start of the fillet weld operation that the welding parameters (Amps, Volts, and Travel Speed) and preheat temperature were in accordance with WPS -F1200A. This QA Inspector verified that the 7018M electrodes being used to perform the fillet weld operation were stored and removed from a heated quiver. The planar offset inspection performed by QC Inspector Mr. Junior Daquinag was in-process at the end of the QA Inspectors' shift.

This QA Inspector randomly observed ABF Welder Mr. Jeremy Dolman performing the back-gouge operation on OBG Bottom "D" plate section 12W ~ 13W per the plasma arc process to back-gouge the weld to sound metal in preparation to weld the second side of the double groove weld. The plasma-arc gouging process was in-process at the end of this QA Inspectors' shift.
