**DEPARTMENT OF TRANSPORTATION**

Contract #: 04-0120F4Cty: SF/ALA Rte: 80 PM: 13.2/13.9File #: 1x.28**WELDING INSPECTION REPORT****Resident Engineer:** Casey, William**Address:** 333 Burma Road**City:** Oakland, CA 94607**Report No:** WIR-026614**Date Inspected:** 02-Nov-2011**Project Name:** SAS Superstructure**OSM Arrival Time:** 630**Prime Contractor:** American Bridge/Fluor Enterprises, a JV**OSM Departure Time:** 1730**Contractor:** American Bridge/Fluor Enterprises, a JV**Location:** On Site**CWI Name:** Pat Swain**CWI Present:** Yes No**Inspected CWI report:** Yes No N/A**Rod Oven in Use:** Yes No N/A**Electrode to specification:** Yes No N/A**Weld Procedures Followed:** Yes No N/A**Qualified Welders:** Yes No N/A**Verified Joint Fit-up:** Yes No N/A**Approved Drawings:** Yes No N/A**Approved WPS:** Yes No N/A**Delayed / Cancelled:** Yes No N/A**Bridge No:** 34-0006**Component:** OBG Segments**Summary of Items Observed:**

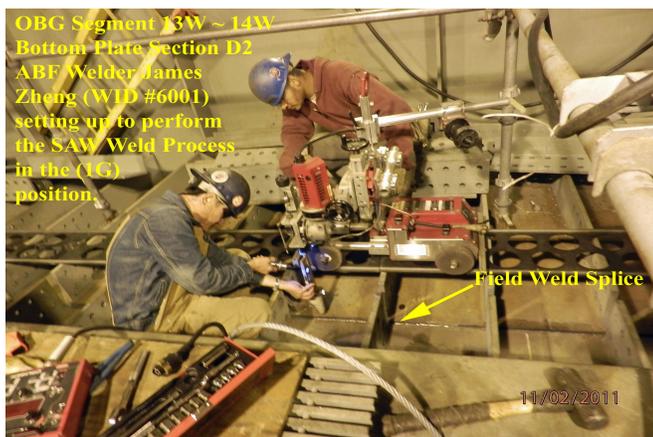
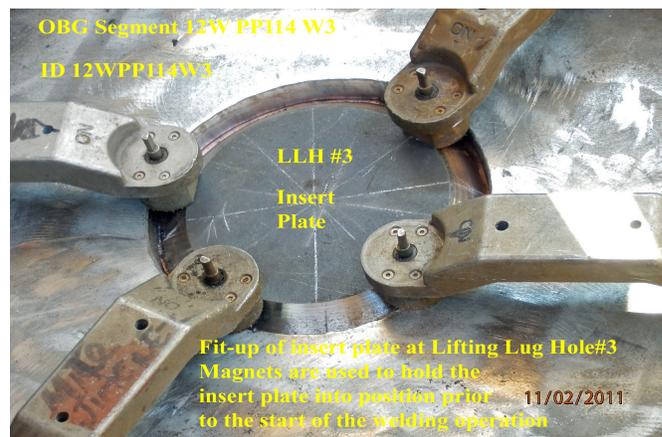
This QA Inspector randomly observed ABF welder Mr. Salvador Sandoval (Welder ID 2202) performing the fit-up operation of LLH #3 on the exterior side of OBG 12W at Panel Point (PP) 114 LLH #3 (12WPP114W3 - LLH-3), The thickness of the LLH insert plate was 30 mm. This QA Inspector observed ABF QC Inspector Mr. Pat Swain perform the offset measurement and root-gap measurement after ABF welder Mr. Sandoval completed the fit-up operation of the LLH insert plate on LLH #3. The offset and root gap inspection results performed by Mr. Pat Swain were in accordance with the contract specifications and the WPS. Afterwards, this QA Inspector observed ABF welder Mr. Sandoval performing the Shielded Metal Arc Welding (SMAW) process in the (1G) position. This QA Inspector observed Mr. Pat Swain verify prior to the start of welding operation that the welding parameters and the preheat temperature were in accordance with WPS-1050A-CU.
