DEPARTMENT OF TRANSPORTATION

Contract #: 04-0120F4Cty: SF/ALA Rte: 80 PM: 13.2/13.9File #: 1.28**WELDING INSPECTION REPORT****Resident Engineer:** Casey, William**Address:** 333 Burma Road**City:** Oakland, CA 94607**Report No:** WIR-026618**Date Inspected:** 01-Nov-2011**Project Name:** SAS Superstructure**OSM Arrival Time:** 700**Prime Contractor:** American Bridge/Fluor Enterprises, a JV**OSM Departure Time:** 1530**Contractor:** American Bridge/Fluor Enterprises, a JV**Location:** Jobsite

Bridge No: 34-0006**Summary of Items Observed:**

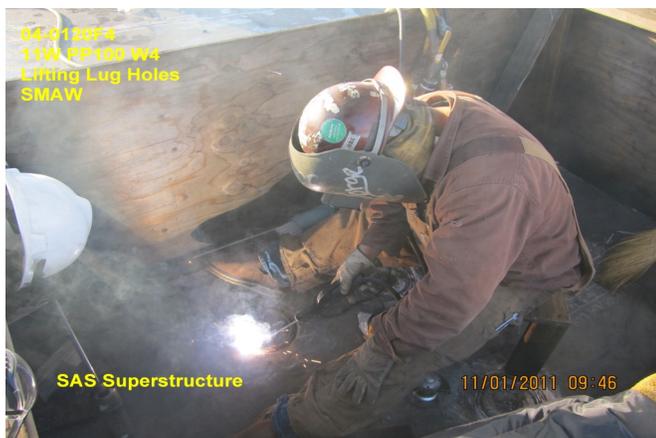
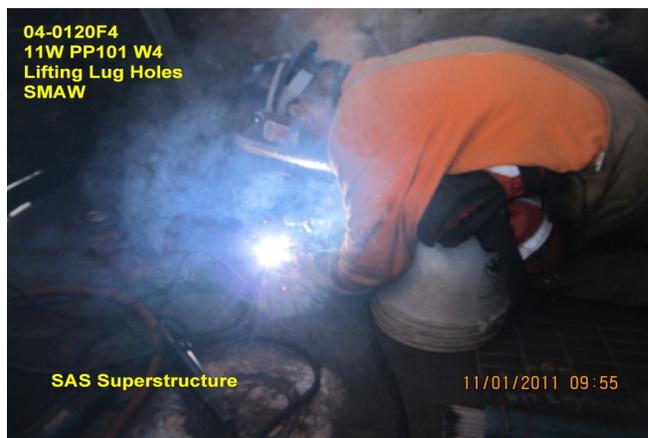
The QA inspector observed the QC inspector identified as John Pagliero measure the planar offset of the lifting lug hole insert as well as the root gap of the joint and the QA inspector verified that both were within tolerance and in accordance with ABF-WPS-D15-1050A-CU. The QA inspector observed ABF welder Jorge Lopez ID# 6149 preheat the joint to 50°F prior to performing Shielded Metal Arc Welding (SMAW) in the 1G flat position on Lifting Lug Hole (LLH) #4 located at 11W PP101 W4. The QA inspector observed the QC inspector monitoring the progress to ensure the welding parameters were in compliance pertaining to ABF-WPS-D15-1050A-CU. The parameters were recorded as (Amperes=134). The QA inspector randomly observed the ABF welder grind and blend the start and stop areas of the weld throughout the joints depth. The QA inspector made subsequent observations throughout the shift to monitor quality and the QA inspector noted that the work on the exterior side of the LLH was completed on this date and appeared to be in general conformance

The QA inspector observed the QC inspector identified as John Pagliero measure the planar offset of the lifting lug hole insert as well as the root gap of the joint and the QA inspector verified that both were within tolerance and in accordance with ABF-WPS-D15-1050A-CU. The QA inspector observed ABF welder Jorge Lopez ID# 6149 preheat the joint to 50°F prior to performing Shielded Metal Arc Welding (SMAW) in the 1G flat position on Lifting Lug Hole (LLH) #2 located at 11W PP101 W4. The QA inspector observed the QC inspector monitoring the progress to ensure the welding parameters were in compliance pertaining to ABF-WPS-D15-1050A-CU. The parameters were recorded as (Amperes=135). The QA inspector randomly observed the ABF welder grind and blend the start and stop areas of the weld throughout the joints depth. The QA inspector made subsequent observations throughout the shift to monitor quality and the QA inspector noted that the work on the exterior side of the LLH was completed on this date and appeared to be in general conformance with the contract documents.

The QA inspector observed the QC inspector identified as John Pagliero measure the planar offset of the lifting lug hole insert as well as the root gap of the joint and the QA inspector verified that both were within tolerance and in accordance with ABF-WPS-D15-1050A-CU. The QA inspector observed ABF welder Mike Jimenez ID# 4671 preheat the joint to 50°F prior to performing SMAW in the 1G flat position on LLH #3 located at 11W PP100 W3. The QA inspector observed the QC inspector monitoring the progress to ensure the welding parameters were in compliance pertaining to ABF-WPS-D15-1050A-CU. The parameters were recorded as (Amperes=134). The QA inspector randomly observed the ABF welder grind and blend the start and stop areas of the weld throughout the joints depth. The QA inspector made subsequent observations throughout the shift to monitor quality and the QA inspector noted that the work on the exterior side of the LLH was completed on this date and appeared to be in general conformance with the contract documents.

The QA inspector observed the QC inspector identified as John Pagliero measure the planar offset of the lifting lug hole insert as well as the root gap of the joint and the QA inspector verified that both were within tolerance and in accordance with ABF-WPS-D15-1050A-CU. The QA inspector observed ABF welder Mike Jimenez ID# 4671 preheat the joint to 50°F prior to performing SMAW in the 1G flat position on LLH #2 located at 11W PP100 W3. The QA inspector observed the QC inspector monitoring the progress to ensure the welding parameters were in compliance pertaining to ABF-WPS-D15-1050A-CU. The parameters were recorded as (Amperes=136). The QA inspector randomly observed the ABF welder grind and blend the start and stop areas of the weld throughout the joints depth. The QA inspector made subsequent observations throughout the shift to monitor quality and the QA inspector noted that the work on the exterior side of the LLH was in progress and appeared to be in general conformance with the contract documents.
