Contract #: 04-0120F4Cty: SF/ALA Rte: 80 PM: 13.2/13.9File #: 1x.28**WELDING INSPECTION REPORT****Resident Engineer:** Casey, William**Address:** 333 Burma Road**City:** Oakland, CA 94607**Report No:** WIR-026640**Date Inspected:** 05-Nov-2011**Project Name:** SAS Superstructure**OSM Arrival Time:** 630**Prime Contractor:** American Bridge/Fluor Enterprises, a JV**OSM Departure Time:** 1530**Contractor:** American Bridge/Fluor Enterprises, a JV**Location:** Jobsite**CWI Name:** John Pagliero**CWI Present:** Yes No**Inspected CWI report:** Yes No N/A**Rod Oven in Use:** Yes No N/A**Electrode to specification:** Yes No N/A**Weld Procedures Followed:** Yes No N/A**Qualified Welders:** Yes No N/A**Verified Joint Fit-up:** Yes No N/A**Approved Drawings:** Yes No N/A**Approved WPS:** Yes No N/A**Delayed / Cancelled:** Yes No N/A**Bridge No:** 34-0006**Component:** OBG Segments**Summary of Items Observed:**

OBG Deck Plate Lifting Lug Holes (LLH) on Segment 11W:

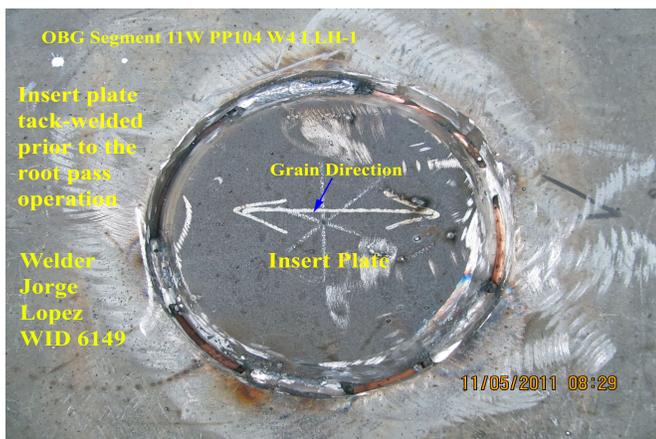
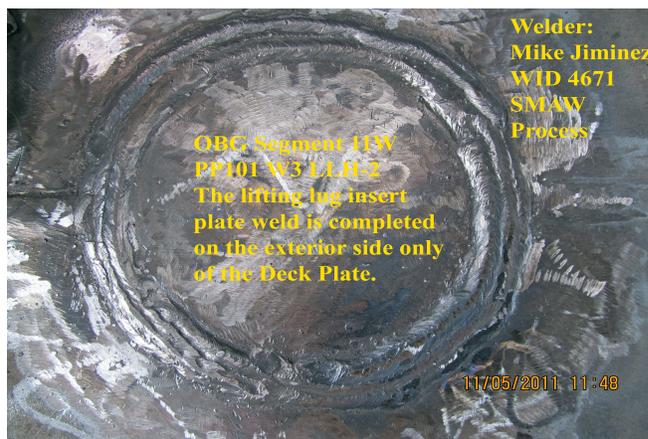
The welding operation observed on this date appeared to be in general compliance with WPS-1050A-CU and the contract specifications.
