Contract #: 04-0120F4Cty: SF/ALA Rte: 80 PM: 13.2/13.9File #: 1.28**WELDING INSPECTION REPORT****Resident Engineer:** Casey, William**Address:** 333 Burma Road**City:** Oakland, CA 94607**Report No:** WIR-026665**Date Inspected:** 04-Nov-2011**Project Name:** SAS Superstructure**OSM Arrival Time:** 700**Prime Contractor:** American Bridge/Fluor Enterprises, a JV**OSM Departure Time:** 1530**Contractor:** American Bridge/Fluor Enterprises, a JV**Location:** Jobsite

Bridge No: 34-0006**Summary of Items Observed:**

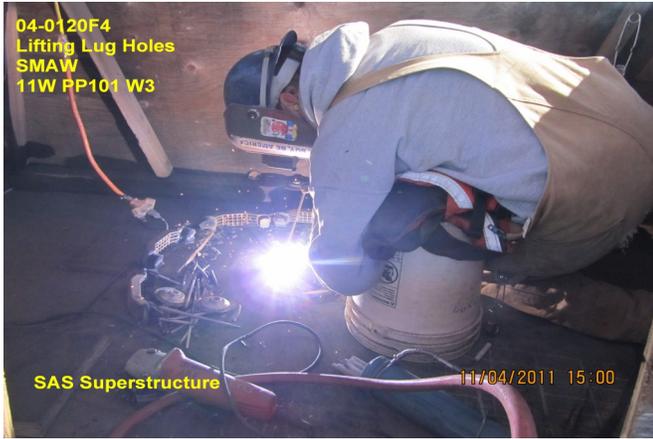
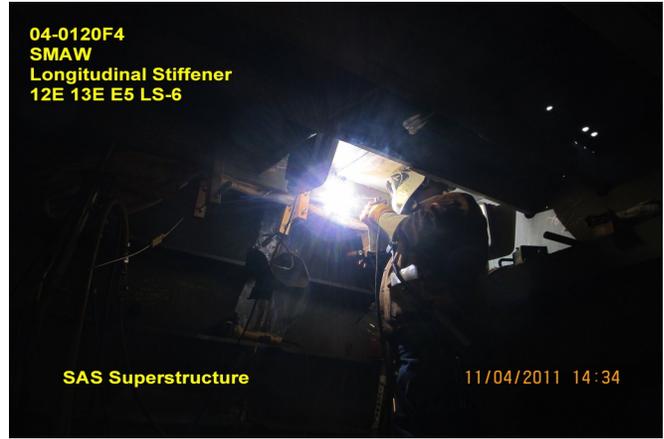
The QA inspector made random observations of ABF welder Mike Jimenez, ID# 4671 performing Shielded Metal Arc Welding (SMAW) in the 1G flat position on Lifting Lug Hole (LLH) #1 located at 11W PP101 W3. The QA inspector observed QC inspector John Pagliero monitoring the progress to ensure the welding parameters was in compliance pertaining to ABF-WPS-D15-1050A-CU. The parameters were recorded as (Amperes=180). The QA inspector made subsequent observations throughout the shift to monitor quality. The QA inspector noted that the work on the exterior side of the LLH was completed on this date and appeared to be in general conformance with the contract documents.

The QA inspector observed QC inspector John Pagliero measure the planar offset and the root gap of LLH #2 insert located at 11W PP103 W3 and verified that the results were in compliance. The QA inspector observed ABF welder Mike Jimenez ID #4671 preheat the joint to 50°F and began welding utilizing the SMAW method in the 1G flat position. The welder began with 1/8 inch diameter E7018H4R electrodes at 135 amperes for the root pass and the balance with 3/16 inch diameter electrodes at 270 amperes. The QA inspector observed the QC inspector monitoring the progress to ensure the welding parameters was in compliance pertaining to ABF-WPS-D15-1050A-CU. The QA inspector made subsequent observations throughout the shift to monitor quality and noted that the work was completed on this date and appeared to be in general conformance with the contract documents.

The QA inspector randomly observed ABF welder Mike Jimenez ID# 4671 preheat the joint to 50°F prior to performing SMAW in the 1G flat position on LLH #3 located at 11W PP101 W3. The QA inspector observed the QC inspector identified as John Pagliero measure the joint fit-up and found it to be acceptable and within compliance. The QA inspector observed the QC inspector monitoring the progress to ensure the welding parameters were in compliance pertaining to ABF-WPS-D15-1050A-CU. The parameters were recorded as (Amperes=180). The QA inspector randomly observed the ABF welder grind and blend the start and stop areas of the weld throughout the joints depth. The QA inspector made subsequent observations throughout the shift to monitor quality and noted that the work on the exterior side of the LLH was in progress and appeared to be in general conformance with the contract documents.

The QA inspector randomly observed ABF welder Fred Kaddu ID#2188 fit up the misaligned joint of longitudinal stiffener -6 at 12E 13E E5 in accordance with ABF-RFI-002616R00. The QA inspector observed QC inspector Fred Von Hoff monitoring the progress to ensure the welding parameters were in compliance pertaining to ABF-WPS-D15-1012-3. The parameters were recorded as (Amperes=128). The QA inspector observed the QC inspector verify that the inter-pass temperatures of the E9018 electrodes were in compliance and the QA inspector made subsequent observations throughout the shift to monitor quality and noted that the work on the interior side of the OBG was in progress and appeared to be in general conformance with the contract documents.
