DEPARTMENT OF TRANSPORTATION

Contract #: 04-0120F4Cty: SF/ALA Rte: 80 PM: 13.2/13.9File #: 1.28**WELDING INSPECTION REPORT****Resident Engineer:** Casey, William**Address:** 333 Burma Road**City:** Oakland, CA 94607**Report No:** WIR-026679**Date Inspected:** 09-Nov-2011**Project Name:** SAS Superstructure**OSM Arrival Time:** 700**Prime Contractor:** American Bridge/Fluor Enterprises, a JV**OSM Departure Time:** 1730**Contractor:** American Bridge/Fluor Enterprises, a JV**Location:** Jobsite

Bridge No: 34-0006**Component:** SAS OBG**Summary of Items Observed:**

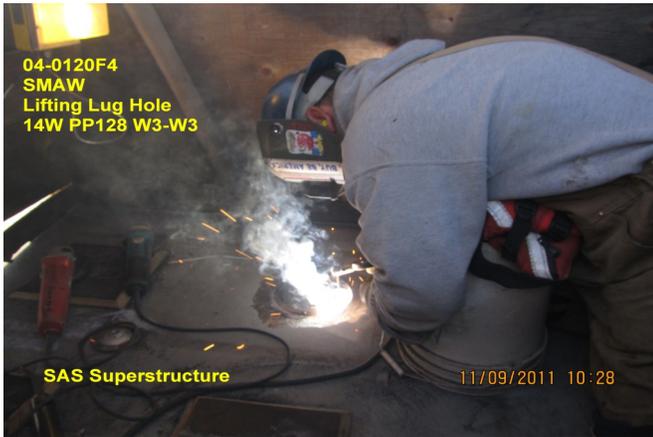
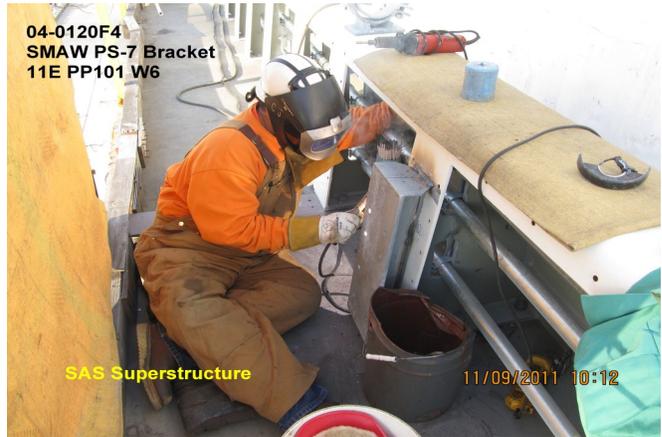
This QA Inspector made random observations of ABF welding personnel Jorge Lopez ID# 6149 perform the Shielded Metal Arc Welding process (SMAW) in the 1G flat position on Lifting Lug Hole (LLH) 14W PP128 W4-W1. This QA Inspector observed QC Inspector Sal Merino measure the pre-heat temperature to verify a minimum of 10°C was achieved. This QA Inspector also observed the QC Inspector monitoring the welding and verifying that the parameters were in compliance pertaining to ABF-WPS-D15-1050A-CU. The parameters were recorded as (Amperes=195) utilizing a 4.0 mm E7018-H4R electrode. During in process welding, this QA Inspector noted that the QC Inspector measured the inter-pass temperatures to maintain a heat range below 230°C. This QA Inspector made subsequent observations throughout the shift to monitor quality. Upon completion of the exterior side of LLH W1, the ABF welder began preparations on LLH W2 at the same location as noted above. This QA Inspector observed the welder grind and blend the edges of the hole utilizing a small disc grinder and installed the 20 mm plate to make up the BU-4a joint. This QA Inspector observed the QC Inspector measure the

planar offset to be within 1 mm and this QA Inspector found it to be acceptable. The QC Inspector verified the pre-heat temperature to be a minimum of 10°C and the ABF welder commenced welding utilizing the SMAW process in the 1G flat position. This QA Inspector noted that the root pass was performed using a 3.2 mm electrode and a 4.0 mm electrode mid joint followed by a 4.8 mm electrode in the final passes. This QA Inspector noted that the QC Inspector was monitoring the welding and verifying that the parameters were in conformance with the above noted WPS. This QA Inspector made subsequent observations throughout the shift to monitor quality and noted that the work on the exterior side of LLH's W1 and W2 were completed on this date and appeared to be in general conformance with the contract documents.

This QA Inspector randomly observed ABF welding personnel Mike Jimenez ID# 4671 pre-heat the joint to 10°C prior to performing SMAW in the 1G flat position on LLH 14W PP128 W3-W3. This QA inspector observed the QC inspector Sal Merino measure the joint fit-up and found it to be acceptable and within compliance. This QA Inspector observed the QC Inspector monitor the inter-pass temperatures and monitor the welding to ensure the parameters were in compliance pertaining to ABF-WPS-D15-1050A-CU. The parameters were recorded as (Amperes=180) utilizing a 4.0 E7018-H4R electrode. This QA Inspector randomly observed the ABF welder grind and blend the start and stop areas of the weld throughout the joints depth. This QA Inspector made subsequent observations throughout the shift to monitor quality and noted that the work on the exterior side of LLH W3 was completed on this date and appeared to be in general conformance with the contract documents. This QA Inspector observed the QC Inspector measure the planar offset on the 20 mm plate for the BU-4a joint at 14W PP128 W3-W4. Upon approval of the fit-up the ABF welder pre-heated the joint to a minimum of 10°C and began welding in the SMAW process in the 1G flat position utilizing a 3.2 mm E7018-H4R electrode for the root pass. This QA Inspector randomly observed the QC Inspector monitor the welding and verifying that the parameters were in conformance with the above noted WPS. This QA Inspector made subsequent observations throughout the shift to monitor quality and noted that the work on the exterior side of LLH's W3 and W4 were completed on this date and appeared to be in general conformance with the contract documents.

This QA Inspector observed F.W. Spencer welding personnel Curtis Jump ID# 7326 fit-up a PS-7 bracket on the crossbeam side of the PP100-PP101 barricade located at 11W PP101 W6. Welding was performed in the flat (2F) position. The QA Inspector observed QC inspector Steve Jensen monitoring welding and to ensure the parameters were in compliance pertaining to WPS-FWS Fillets Murex SFOBB Revision 1. The welder was observed implementing E7018-H4R Murex electrodes. This QA Inspector made subsequent observations throughout the shift to monitor quality. The FW Spencer welder completed the PS-7 bracket and relocated to 11E 12E E6 for installation of a PS-5 bracket. The welder utilized the SMAW process in the flat (2F) position and incorporated the E7018-H4R Murex electrodes conforming to the above welding procedure. This QA Inspector observed the QC Inspector monitoring welding and to ensure the parameters were in compliance and this QA Inspector made subsequent observations throughout the shift to monitor quality. Upon completion of the welding of the PS-5 bracket the welder began installation of a PS-5 bracket at 11E PP101 W6. This QA Inspector randomly observed the QC Inspector monitor the welding to ensure the parameters were in compliance pertaining to WPS-FWS Fillets Murex SFOBB Revision 1. This QA Inspector made subsequent observations throughout the shift to monitor quality and noted that the work was completed on this date and appeared to be in general
