DEPARTMENT OF TRANSPORTATION

Office of Structural Materials

Contract #: 04-0120F4Cty: SF/ALA Rte: 80 PM: 13.2/13.9File #: 1.28**WELDING INSPECTION REPORT****Resident Engineer:** Casey, William**Address:** 333 Burma Road**City:** Oakland, CA 94607**Report No:** WIR-026689**Date Inspected:** 11-Nov-2011**Project Name:** SAS Superstructure**OSM Arrival Time:** 700**Prime Contractor:** American Bridge/Fluor Enterprises, a JV**OSM Departure Time:** 1530**Contractor:** American Bridge/Fluor Enterprises, a JV**Location:** Job Site**CWI Name:** Bernie Docena**CWI Present:** Yes No**Inspected CWI report:** Yes No N/A**Rod Oven in Use:** Yes No N/A**Electrode to specification:** Yes No N/A**Weld Procedures Followed:** Yes No N/A**Qualified Welders:** Yes No N/A**Verified Joint Fit-up:** Yes No N/A**Approved Drawings:** Yes No N/A**Approved WPS:** Yes No N/A**Delayed / Cancelled:** Yes No N/A**Bridge No:** 34-0006**Component:** SAS OBG**Summary of Items Observed:**

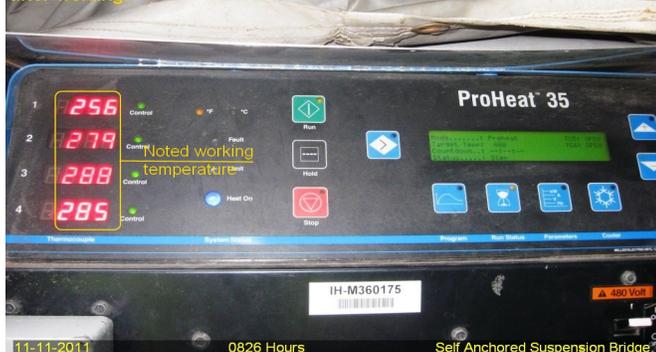
At OBG 13E/14E bottom plate 'D1' (Y=600mm to Y=3100mm) inside, ABF personnel were noted using the Miller Proheat 35 Induction Heating System to preheat and maintain the required temperature pre/post during/after welding.

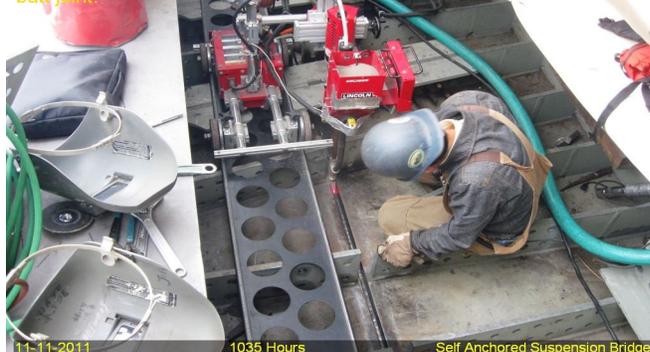
At OBG 13E/14E bottom plate 'D1' (Y=600mm to Y=3100mm) inside, ABF welder James Zhen was observed performing 1G Submerged Arc Welding (SAW) welding all pass on 30/35mm unequal thickness splice butt joint.
