DEPARTMENT OF TRANSPORTATION

Contract #: 04-0120F4Cty: SF/ALA Rte: 80 PM: 13.2/13.9File #: 1x.28**WELDING INSPECTION REPORT****Resident Engineer:** Casey, William**Address:** 333 Burma Road**City:** Oakland, CA 94607**Report No:** WIR-026695**Date Inspected:** 12-Nov-2011**Project Name:** SAS Superstructure**OSM Arrival Time:** 700**Prime Contractor:** American Bridge/Fluor Enterprises, a JV**OSM Departure Time:** 1530**Contractor:** American Bridge/Fluor Enterprises, a JV**Location:** Job Site**CWI Name:** Fred Von Hoff**CWI Present:** Yes No**Inspected CWI report:** Yes No N/A**Rod Oven in Use:** Yes No N/A**Electrode to specification:** Yes No N/A**Weld Procedures Followed:** Yes No N/A**Qualified Welders:** Yes No N/A**Verified Joint Fit-up:** Yes No N/A**Approved Drawings:** Yes No N/A**Approved WPS:** Yes No N/A**Delayed / Cancelled:** Yes No N/A**Bridge No:** 34-0006**Component:** OBG Segments**Summary of Items Observed:**

OBG Deck Plate "A" Lifting Lug Hole (LLH) Repair Welding on OBG Segment 14E:

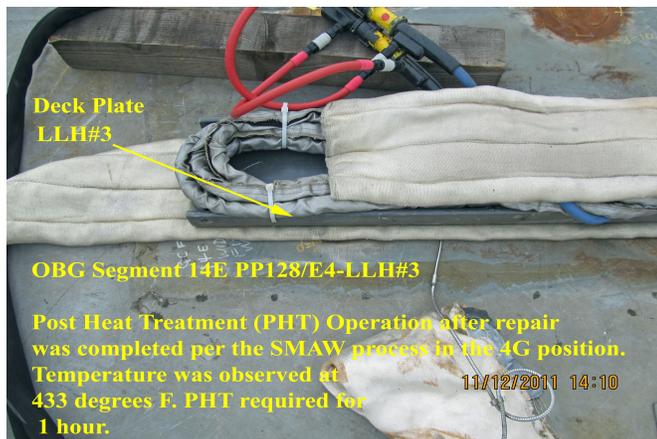
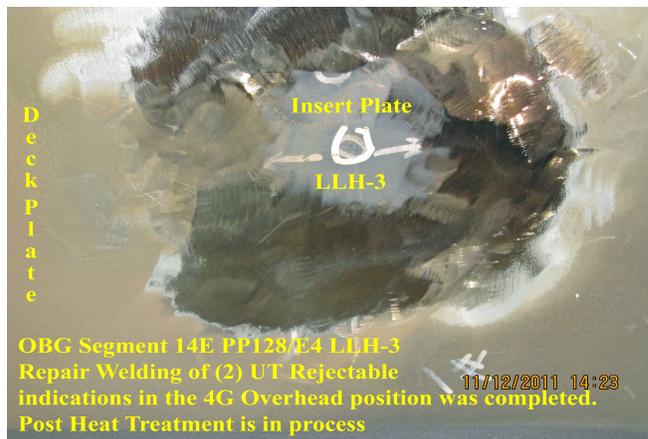
This QA Inspector randomly observed ABF welder Mr. Salvador Sandoval (Welder ID 2202) performing the repair weld operation at (2) locations on LLH insert plate #3 per the Shielded Metal Arc Welding (SMAW) process in the (4G) overhead position on the interior side of OBG 14 East Deck Plate "A" at Panel Point (PP) 128 - (14EPP128E4-LLH-3). The reason for the repair weld operation was that (2) ultrasonic rejectable indications were detected. The thickness of the LLH insert plate #3 was 20 mm. This QA Inspector observed QC Inspector Mr. Fred Von Hoff verify prior to the start of the repair weld operation that the welding parameters (Amps, Volts and Travel Speed) and the preheat temperature of 225 degrees F were established and in accordance with WPS-D1. 5-1004 Repair for Seismic Performance Critical Member (SPCM) of Deck Plate "A" on OBG Segment 14 East. This QA Inspector observed that ABF welder Mr. Sandoval completed the repair weld operation of (2) groove weld excavations on the interior side of LLH insert plate ##3. Afterwards, the ABF personnel placed the heat induction blanket on the exterior side of Deck Plate "A" and the temperature was being ramped up between 315 and 600 degrees F to start the post heat treatment (PHT) operation on LLH insert plate #3. The required time of the PHT operation was for one (1) hour.

This QA Inspector met with QC Inspector Mr. Fred Von Hoff to discuss the depths of the (2) groove weld excavations on the interior side of Deck Plate "A" from the ultrasonic rejectable indications that were detected on OBG Segment 14 East at PP128 Grid line E4 of LLH insert plate weld #3. The Deck Plate "A" on OBG Segment 14 East is designated as an SPCM member. Mr. Fred Von Hoff informed this QA Inspector that the depths of the groove weld excavations on the interior side of Lifting Lug Insert Plate weld #3 were three (3) mm and eleven (11) mm. This QA Inspector needed to verify the depths of the groove weld excavations to ensure that the depths of the groove weld excavations did not exceed 65% of the weld size. The thickness of Deck Plate "A" was 20 mm and 65 percent of the Deck Plate thickness is 13 mm therefore the two (2) groove weld excavations were classified as a non-critical weld repair.
