Contract #: 04-0120F4Cty: SF/ALA Rte: 80 PM: 13.2/13.9File #: 1.28**WELDING INSPECTION REPORT**

**Report No:** WIR-026700  
**Date Inspected:** 12-Nov-2011

**Project Name:** SAS Superstructure  
**Prime Contractor:** American Bridge/Fluor Enterprises, a JV  
**Contractor:** American Bridge/Fluor Enterprises, a JV

<b>CWI Name:</b>	As noted below	<b>CWI Present:</b>	Yes	No	
<b>Inspected CWI report:</b>	Yes No N/A	<b>Rod Oven in Use:</b>	Yes	No	N/A
<b>Electrode to specification:</b>	Yes No N/A	<b>Weld Procedures Followed:</b>	Yes	No	N/A
<b>Qualified Welders:</b>	Yes No N/A	<b>Verified Joint Fit-up:</b>	Yes	No	N/A
<b>Approved Drawings:</b>	Yes No N/A	<b>Approved WPS:</b>	Yes	No	N/A
		<b>Delayed / Cancelled:</b>	Yes	No	N/A
<b>Bridge No:</b>	34-0006	<b>Component:</b>	SAS OBG

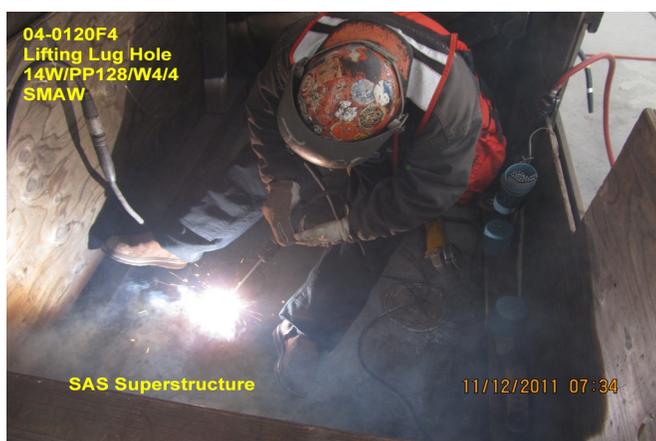
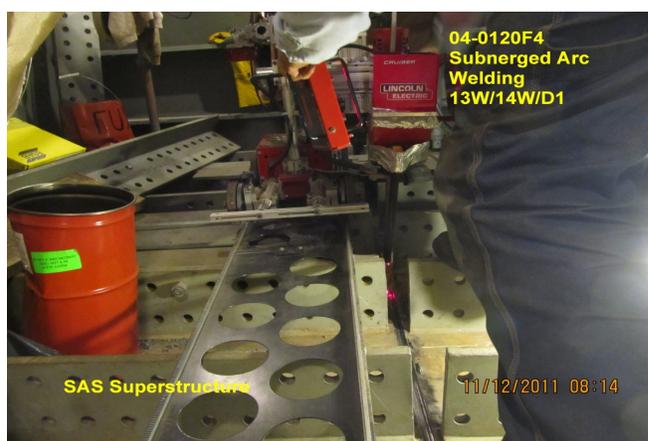
This QA Inspector randomly observed ABF welder Jorge Lopez (Welder ID 6149) performing the Shielded Metal Arc Welding (SMAW) process in the (1G) flat position on the Seismic Performance Critical Member (SPCM) "A" deck lifting lug hole 14W/PP128/W4/W4. This QA Inspector observed QC Inspector Sal Merino verify that the preheat temperature was at the minimum of 10 degrees C and that the welding parameters (Amps=260) were in accordance with ABF-WPS-D15-1050A-CU. This QA Inspector made subsequent observations throughout the shift to monitor quality and noted that the work was completed on this date and appeared to be in general compliance with the approved WPS and the contract specifications.

Metal Arc Welding process (SMAW) in the 1G flat position on the SPCM Lifting Lug Hole (LLH) 14W/PP128/W4/W2. This QA Inspector observed QC Inspector Sal Merino measure the pre-heat temperature to verify a minimum of 10°C was achieved. This QA Inspector also observed the QC Inspector monitoring the welding and verifying that the parameters were in compliance pertaining to ABF-WPS-D15-1050A-CU. The parameters were recorded as (Amperes=230) utilizing a 4.0 mm E7018-H4R electrode. During in process welding, this QA Inspector noted that the QC Inspector measured the inter-pass temperatures to maintain a heat range below 230°C. This QA Inspector made subsequent observations during the shift and noted that the work was completed on this date and appeared to be in general conformance to the contract specifications.

This QA Inspector randomly observed ABF welding operator Rory Hogan (ID3186) performing Submerged Arc Welding (SAW) on “D1” at 13W/14W of the OBG. The Seismic Performance Critical Member (SPCM) joint being welded has a single V-groove butt joint with backing bar that will be removed and back gouged then back welded. This QA Inspector observed QC Inspector Steve Jensen monitoring the welding to ensure the welding parameters were in compliance pertaining to ABF-WPS-D15-4042 B-1. The parameters were recorded as (A=555/V=32.5/TS=365/HI=2.93). The QA inspector made subsequent observations throughout the shift to monitor quality and noted that the work is in progress and appears to be in general conformance to the contract requirements.
