DEPARTMENT OF TRANSPORTATION

Contract #: 04-0120F4Cty: SF/ALA Rte: 80 PM: 13.2/13.9File #: 1.28**WELDING INSPECTION REPORT**

Report No: WIR-026701
Date Inspected: 13-Nov-2011

Project Name: SAS Superstructure
Prime Contractor: American Bridge/Fluor Enterprises, a JV
Contractor: American Bridge/Fluor Enterprises, a JV

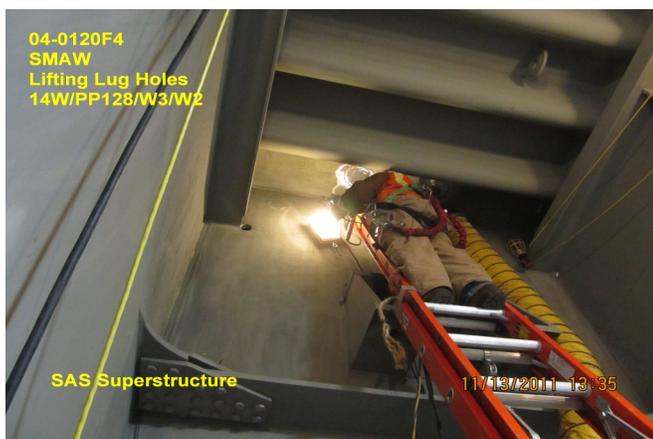
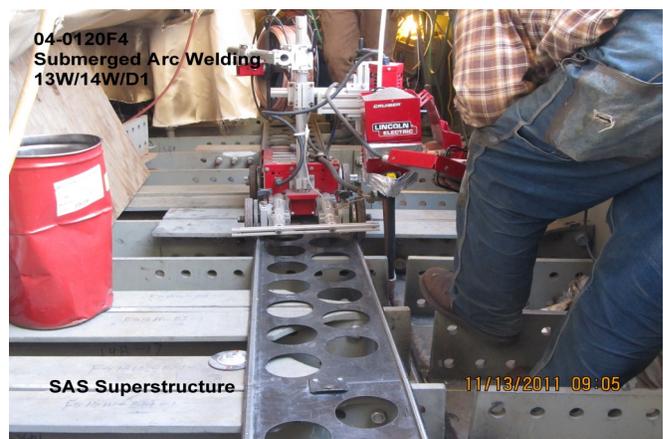
This QA Inspector randomly observed ABF welder Fred Kaddu performing the back-gouge operation of ultrasonic rejectable indications on OBG edge plate “F” section 12W /13W located at Y= 820 mm: (25 mm wide; 90 mm length; and 14 mm in depth), Y= 1365 mm: (25 mm wide; 100 mm length; and 8 mm in depth), Y= 1495 mm: (25 mm wide; 150 mm length; and 9 mm in depth), Y= 1735 mm: (25 mm wide; 85 mm length; and 8 mm in depth).

This QA Inspector randomly observed ABF welding operator Rory Hogan (ID3186) performing Submerged Arc Welding (SAW) on “D1” at 13W/14W of the OBG. The Seismic Performance Critical Member (SPCM) joint being welded has a single V-groove butt joint with backing bar that will be removed and then back welded. This QA Inspector observed QC Inspector Steve Jensen monitoring the welding to ensure the welding parameters were in compliance pertaining to ABF-WPS-D15-4042 B-1. The parameters were recorded as (A=550/V=32.5/TS=400/HI=2.68). The QA inspector made subsequent observations throughout the shift to monitor quality and noted that the work is in progress and appears to be in general conformance to the contract requirements.
