DEPARTMENT OF TRANSPORTATION

Contract #: 04-0120F4Cty: SF/ALA Rte: 80 PM: 13.2/13.9File #: 1x.28**WELDING INSPECTION REPORT****Resident Engineer:** Casey, William**Address:** 333 Burma Road**City:** Oakland, CA 94607**Report No:** WIR-026703**Date Inspected:** 13-Nov-2011**Project Name:** SAS Superstructure**OSM Arrival Time:** 700**Prime Contractor:** American Bridge/Fluor Enterprises, a JV**OSM Departure Time:** 1530**Contractor:** American Bridge/Fluor Enterprises, a JV**Location:** Job Site

Segment 14E

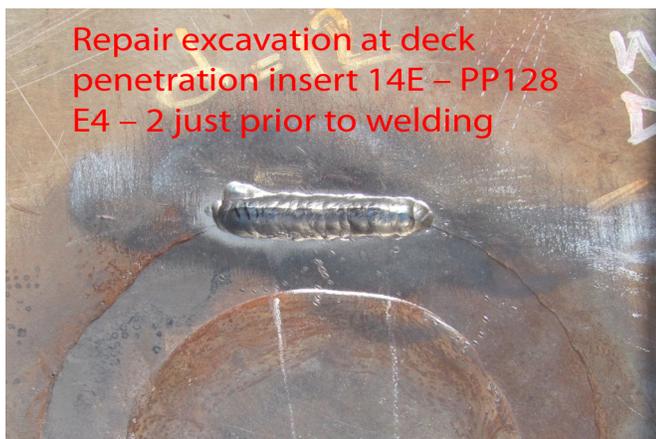
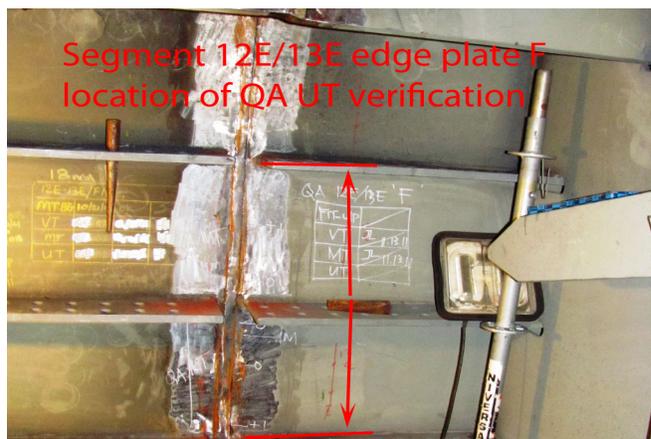
2. The QAI periodically observed ABF approved welders Kevin Kananen, ID-6521, Salvador Sandoval, ID- 2202 and Todd Jackson, ID – 4639 welding lifting lug and vent deck penetration complete joint penetration weld inserts at the following locations.

Welding was performed per the Shielded Metal Arc Welding (SMAW) process in the 1G (flat) position. AB/F QC Inspector Fred Von Hoff was present to monitor the progress and verify that the filler metal and welding parameters were within the limits established by the approved welding Procedure Specification (WPS) identified as ABF-WPS-D1.5-1050A-Rev 0. The work appeared to be in general compliance with contract documents.
