DEPARTMENT OF TRANSPORTATION

Contract #: 04-0120F4Cty: SF/ALA Rte: 80 PM: 13.2/13.9File #: 1.28**WELDING INSPECTION REPORT****Resident Engineer:** Casey, William**Address:** 333 Burma Road**City:** Oakland, CA 94607**Report No:** WIR-026704**Date Inspected:** 13-Nov-2011**Project Name:** SAS Superstructure**OSM Arrival Time:** 700**Prime Contractor:** American Bridge/Fluor Enterprises, a JV**OSM Departure Time:** 1530**Contractor:** American Bridge/Fluor Enterprises, a JV**Location:** Job Site**CWI Name:** Bernie Docena**CWI Present:** Yes No**Inspected CWI report:** Yes No N/A**Rod Oven in Use:** Yes No N/A**Electrode to specification:** Yes No N/A**Weld Procedures Followed:** Yes No N/A**Qualified Welders:** Yes No N/A**Verified Joint Fit-up:** Yes No N/A**Approved Drawings:** Yes No N/A**Approved WPS:** Yes No N/A**Delayed / Cancelled:** Yes No N/A**Bridge No:** 34-0006**Component:** SAS OBG**Summary of Items Observed:**

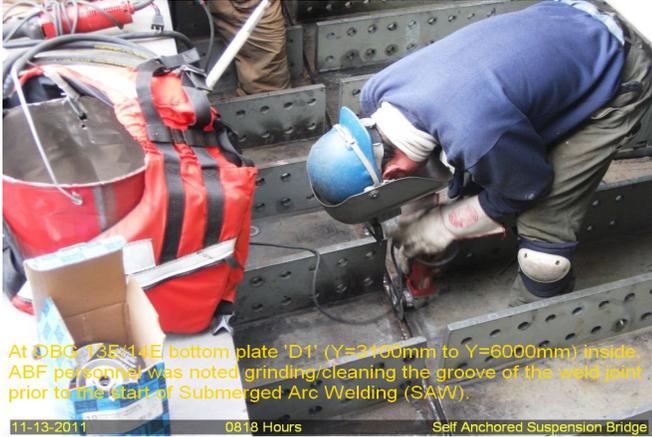
At OBG 13E/14E bottom plate 'D1' (Y=3100mm to Y=6000mm) inside, QA randomly observed ABF certified welder James Zhen ID #6001 continuing to perform 1G (flat position) Submerged Arc Welding (SAW) welding fill pass to cover pass on the unequal plate thickness (35mm/30mm) Complete Joint Penetration (CJP) splice butt joint. The welder was utilizing F7A6-EM12K-H8, 3.2mm electrode with corresponding Esab OK Flux 10.62 flux and implementing Caltrans approved Welding Procedure Specification (WPS) ABF-WPS-D15-4042B-1. The Seismic Performance Critical Member (SPCM) joint being welded has a single V-groove butt joint with backing bar that will be removed then back welded. The plates were preheated to more than 200 degree Fahrenheit using Miller Proheat 35 Induction Heating System heater blankets located at the opposite side of the plate prior/during welding. Welding parameters were monitored by ABF/QC Bernie Docena. Measured welding parameters during welding were 550 amperes, 32.5 volts and 420mm per minute travel speed with calculated heat input of 2.55 Kjoules per mm. QA noted the welding parameters, the workmanship and appearance of the completed fill/cover pass deemed satisfactory. During the shift, cover pass welding was still continuing and should remain tomorrow. The welder has held the preheat of more than 200°F for three more hours after welding as required.
