**DEPARTMENT OF TRANSPORTATION**

Quality Assurance and Source Inspection

Contract #: 04-0120F4Cty: SF/ALA Rte: 80 PM: 13.2/13.9File #: 1.28**WELDING INSPECTION REPORT****Resident Engineer:** Casey, William**Address:** 333 Burma Road**City:** Oakland, CA 94607**Report No:** WIR-026720**Date Inspected:** 16-Nov-2011**Project Name:** SAS Superstructure**OSM Arrival Time:** 700**Prime Contractor:** American Bridge/Fluor Enterprises, a JV**OSM Departure Time:** 1730**Contractor:** American Bridge/Fluor Enterprises, a JV**Location:** Job Site**CWI Name:** Fred Von Hoff**CWI Present:** Yes No**Inspected CWI report:** Yes No N/A**Rod Oven in Use:** Yes No N/A**Electrode to specification:** Yes No N/A**Weld Procedures Followed:** Yes No N/A**Qualified Welders:** Yes No N/A**Verified Joint Fit-up:** Yes No N/A**Approved Drawings:** Yes No N/A**Approved WPS:** Yes No N/A**Delayed / Cancelled:** Yes No N/A**Bridge No:** 34-0006**Component:** OBG Sections**Summary of Items Observed:**

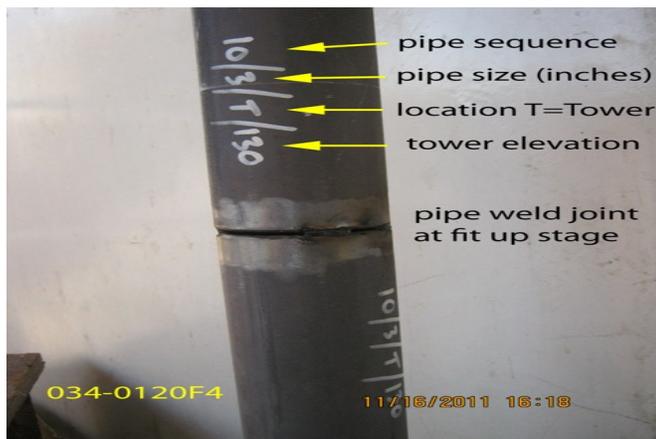
below. This QA Inspector observed QC Inspector Steve Jensen perform a visual inspection of the weld and was informed he had accepted the inspection on weld joint 7/3/T/139. This QA Inspector performed a visual verification and the work appeared to comply with the contract requirements. This QA Inspector observed QC Inspector Steve Jensen perform a fit up inspection and was informed he had accepted the fit up of weld joint 8/3/T/139. This QA Inspector performed a visual verification of the fit up and the work appeared to comply with the contract requirements. This QA Inspector observed QC Inspector Steve Jensen perform a visual inspection on the weld at weld joint 8/3/T/139 and was informed he had accepted the inspection. This QA Inspector performed a visual verification and the work appeared to comply with the contract requirements. This QA Inspector randomly observed Curtis Jump performing SMAW during the production welding of above members and the welding appeared to comply with WPS: 1-12-1 Revision-2. See photo below for weld joint designations.
